ARTICLE *in* GEOSPHERE · DECEMBER 2015

# Geomorphic response to catastrophic flooding in north-central Pennsylvania from Tropical Storm Lee (September 2011): Intersection of fluvial disequilibrium and the legacy of logging

R. Craig Kochel<sup>1</sup>, Benjamin R. Hayes<sup>2</sup>, Jason Muhlbauer<sup>1</sup>, Zac Hancock<sup>1</sup>, and Darin Rockwell<sup>1</sup>

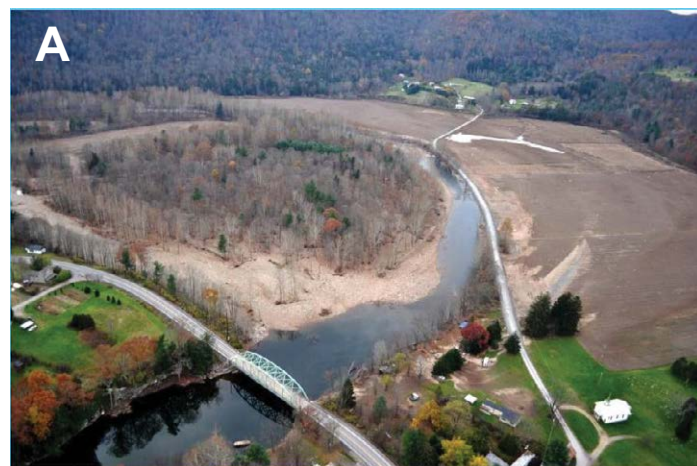
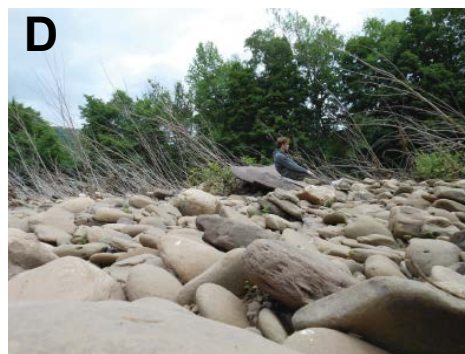
Figure 9. Hillsgrove chute complex on central Loyalsock Creek. (A) Oblique aerial view of the chute. (B) Geomorphic map. (C) Preflood lidar (light detection and ranging) image showing berm and paleochute. (D) Ground view of imbricated gravel in the upstream portion of the chute (flow from right to left). (E) Surface grain-size variation along chute axis.

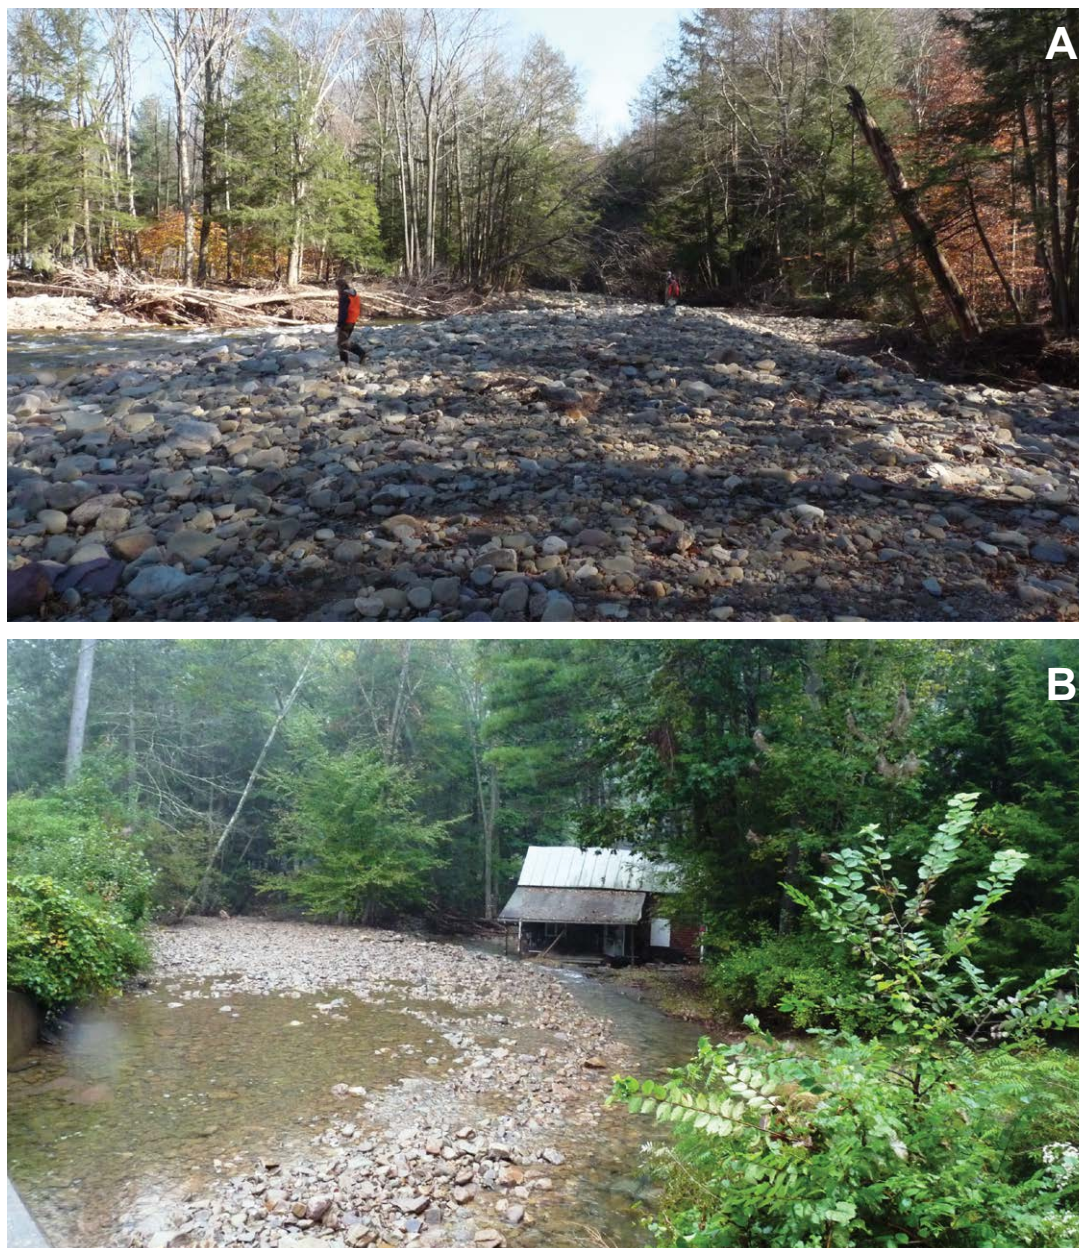
**Figure 12.** Examples of bar aggradation filling channels above floodplain surface. (A) Bar in upper Fishing Creek near Elk Grove. (B) Fill and channel avulsion onto floodplain in Little Bear Creek, tributary to Loyalsock Creek, near Barbours.
