The Geological Society of America  
Reviews in Engineering Geology XXI  
2013

# ***The rise and fall of Mid-Atlantic streams: Millpond sedimentation, milldam breaching, channel incision, and stream bank erosion***

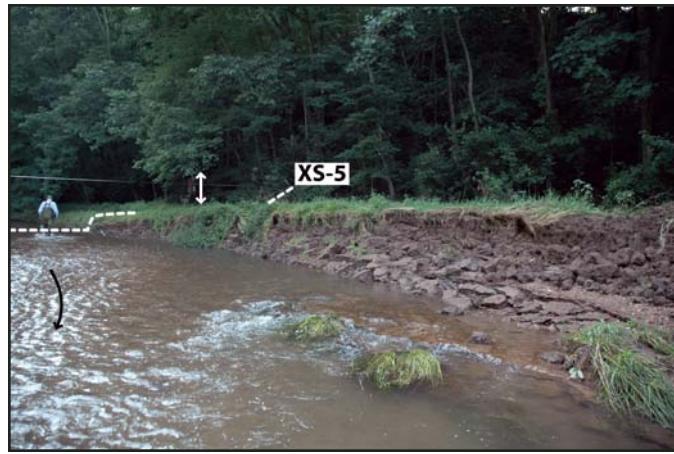
Figure 2. Mass movement occurred along the left bank of the incised Hammer Creek just downstream of XS 5 as a result of wetting and drying of the banks by high flow from a late June 2006 storm. Double arrow indicates person for scale along tape measure at section. Flat surface at top of bank is the level of sedimentation in the millpond. See Figure 5 for location of cross section.

failure at more than 100 breached dam sites in Pennsylvania and Maryland, including sites where dams were breached more than 50 yr ago (Fig. 2).

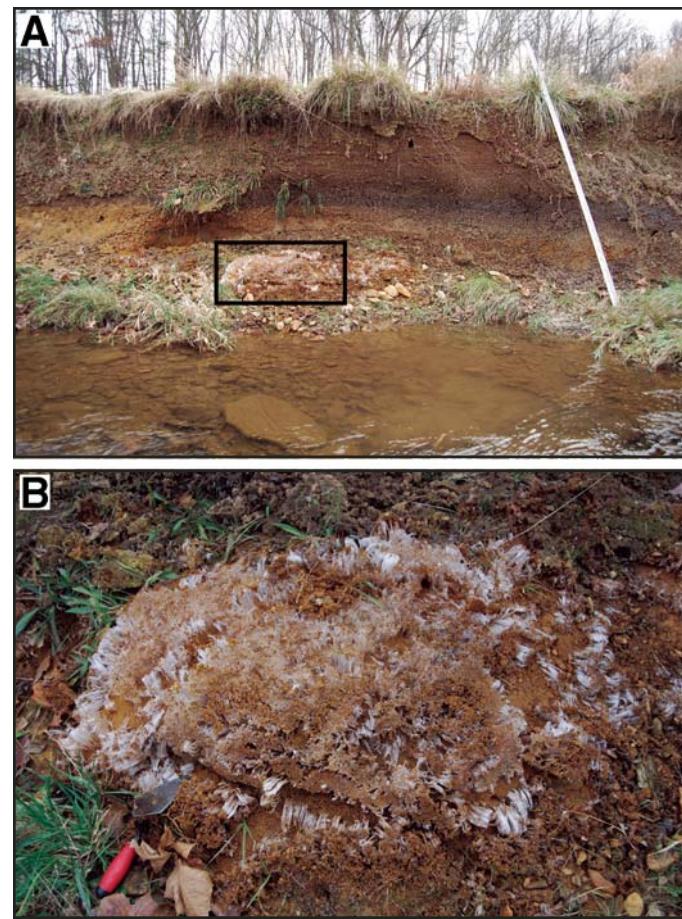
Figure 3. (A) Apron of debris forming on the right bank of a breached millpond on Little Falls, Maryland (see Fig. 1 for location), near the town of Whitehall. Bank height is ~2 m, and downstream is to left. Dark soil at midbank level is the presettlement land surface. The site is close to the valley wall, and the millpond sediment (overlying brown sediment) is thinning toward the original reservoir margin. (B) Freeze-thaw has produced large needles of ice from pore water in bank sediment. As ice needles grew in pores perpendicularly to the bank face (horizontal), a vertical fracture opened parallel to the bank face, causing a large slab of bank to collapse onto the debris apron in the winter of 2008–2009 (photos taken in February 2009). Trowel for scale in lower image.

The action of freeze-thaw directly results in bank erosion by the action of needle ice, as observed by us at numerous sites in the Mid-Atlantic region (Fig. 3) and described by Wolman (1959, p. 215) from his observations along banks of sand, silt, and clay at Watts Branch, Maryland, in December 1955: “Particles are heaved out from the bank by ice crystals and upon melting of the crystals the sediment drops into the stream... slabs of sediment perhaps one foot square containing thin ice lenses have been observed. The action of frost appears to be one of preparation of a veneer of sediment for erosion...”

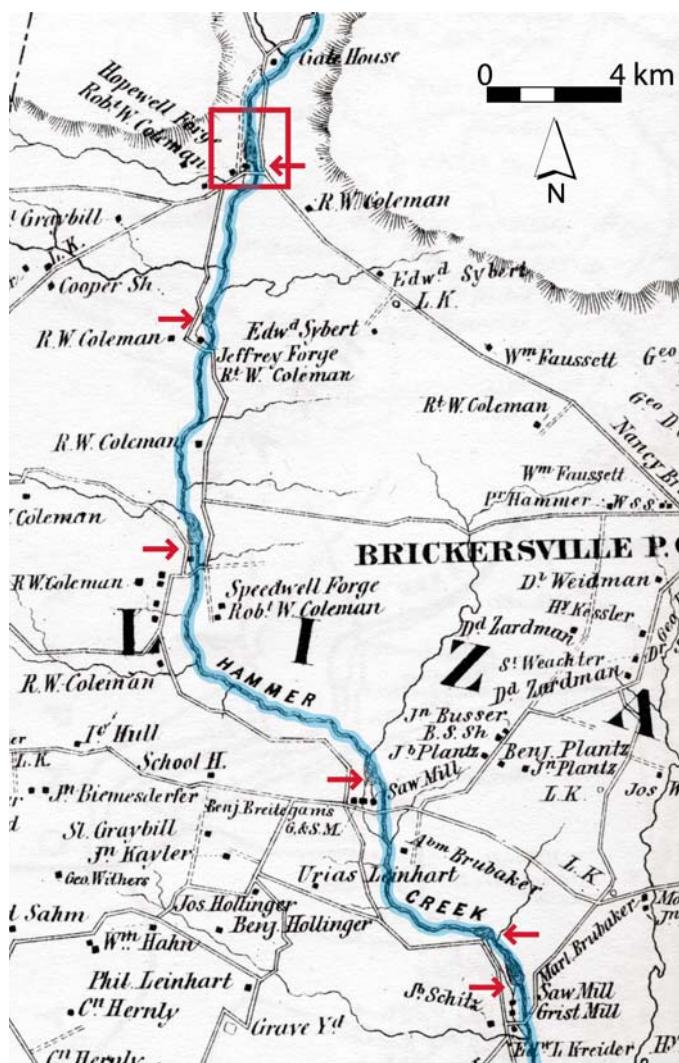
Figure 4. Historic township maps indicate that at least 13 milldams were located along a distance of ~28 km on Hammer Creek in the mid-nineteenth century (Bridgens, 1858). Inset box is area of Figure 5. Earliest milldams were built in the early seventeenth century, and many ponds were partly or nearly filled with sediment by the late nineteenth century. Milldams located in six counties in Pennsylvania and two in Maryland for the nineteenth century, as well as a number of mills per county in the eastern United States as of the 1840 U.S. census, can be viewed at the following Web site: <http://www.fandm.edu/x17479>.

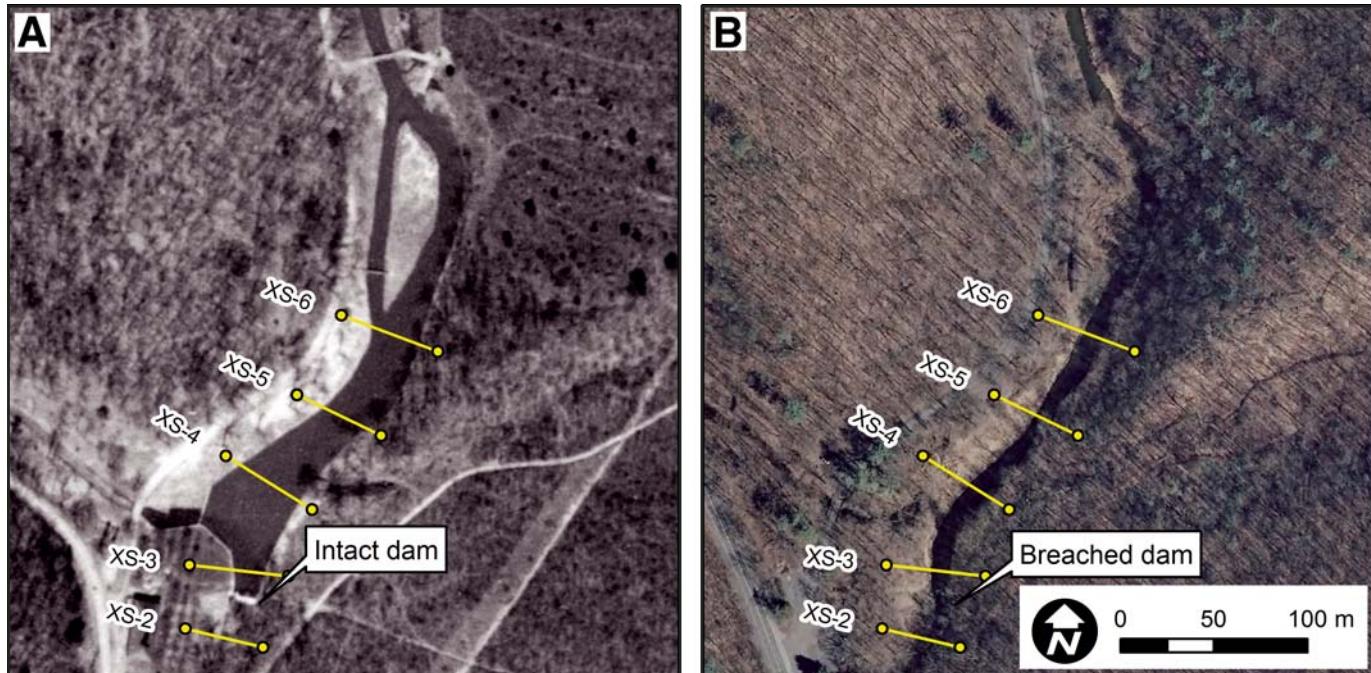
Figure 5. (A) Historic (1940) aerial photo of the Hammer Creek pump station dam showing the reservoir upstream and wing wall connecting the main-stem dam to that on a small tributary (Walnut Run) from the west. The pump station dam was built in 1901–1902 and had substantial sedimentation by the time of this photo. (B) Digital ortho-image from 2003, acquired by the state of Pennsylvania (horizontal resolution 0.6 m), showing the incised stream channel and remnant paired fill terraces from the millpond 2 yr after dam breaching. The dam on Walnut Run is not breached, so this tributary has not yet incised to adjust to the lowered base level on the main stem.

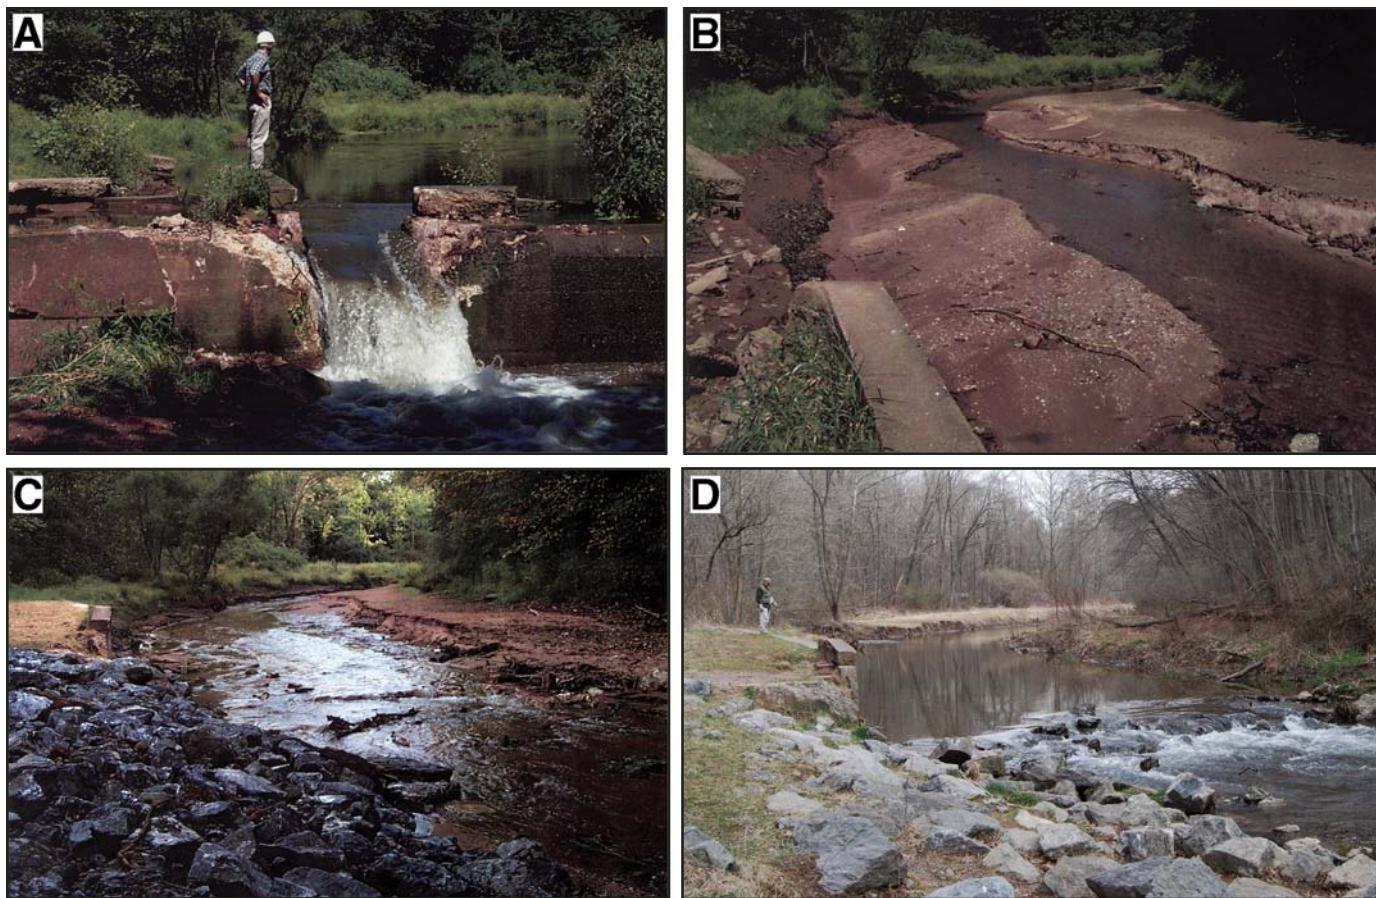
Figure 6. Photos, taken by staff of the Pennsylvania Department of Environmental Protection, document dam breaching and subsequent channel incision at Hammer Creek. All views are looking north, upstream. (A) 5 September 2001, just after the dam was breached. Note person standing on wing wall that attaches this dam to a small dam on a tributary from the west just out of view on the left. Note that historic millpond sediment is graded to the original dam crest. (B) 6 September 2001, showing exposed and eroding fine-grained reservoir sediment. Mesozoic rift basin sedimentary rocks in the watershed, including red shales and sandstones, produce sediment with strong red hues. (C) 27 September 2001, showing the breached reservoir after rocks were placed near the breach and the surface just upstream of the dam was graded. (D) The breached reservoir in April 2011. Note exposed banks upstream of the breach and remnant millpond surface forming paired terraces on each side of the incised stream channel. About 0.5 m of the base of the dam remains in place, as do the ends of the dam on each side of the breach, and rubble from the breached dam was used by anglers to create a pool for fishing.

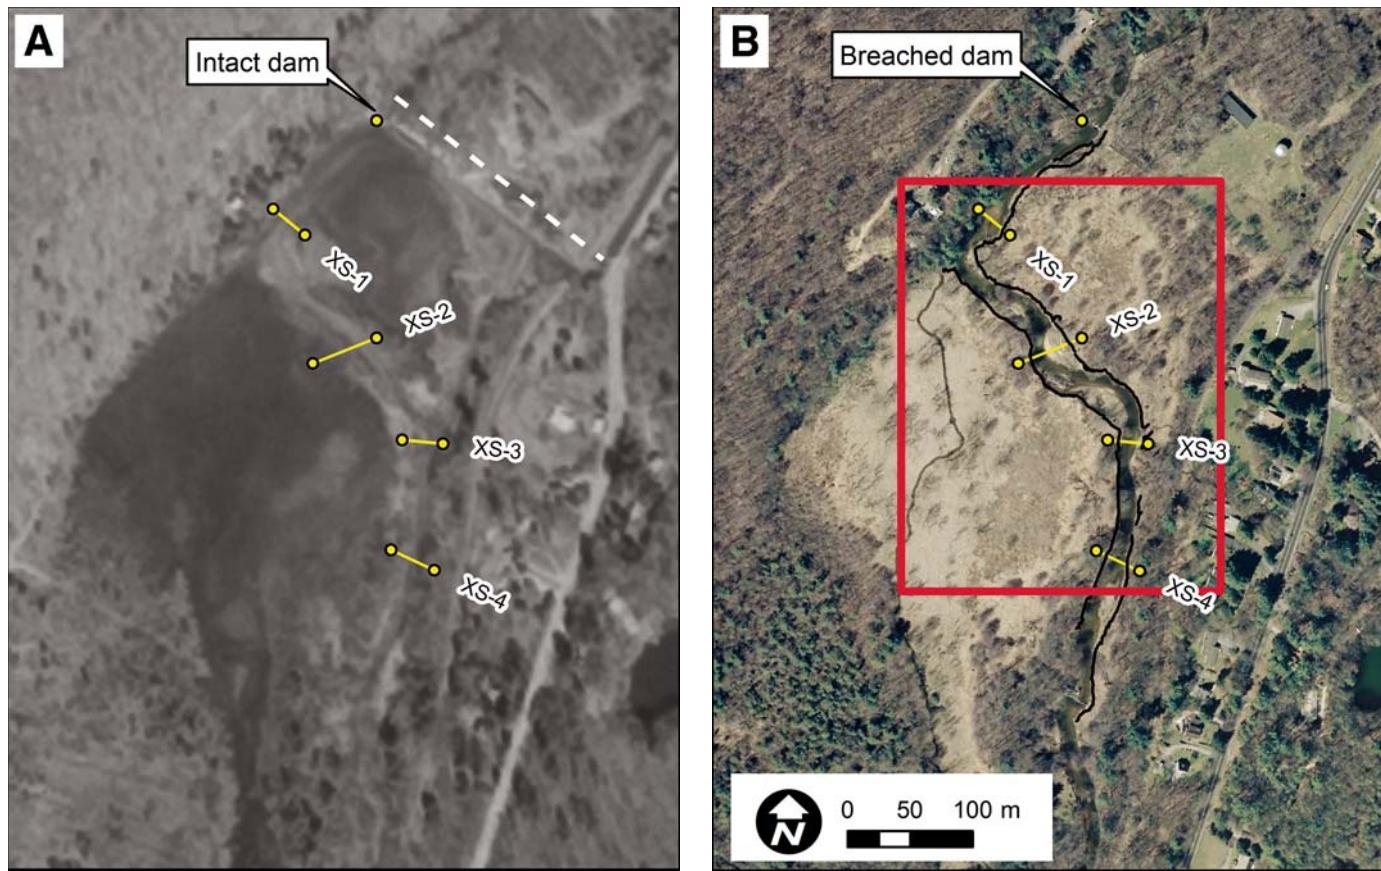
Figure 7. (A) Historic (1968) aerial photo of the Mountain Creek Eaton-Dikeman milldam (213 m long) showing the reservoir and deltaic lobes filling in the reservoir. The dam was built in 1855, and was reported as having substantial sediment infilling by the early twentieth century (see text). (B) Digital ortho-image from 2003, acquired by the state of Pennsylvania (horizontal resolution 0.6 m), showing the incised stream channel and remnant paired fill terraces from the millpond 18 yr after dam breaching. Channel cross sections for this study are shown. Solid black lines represent millpond fill-terrace edge break lines surveyed in 2008; note substantial retreat of the terrace edge from 2003 to 2008 in many places. Red box is area of Figure 13.

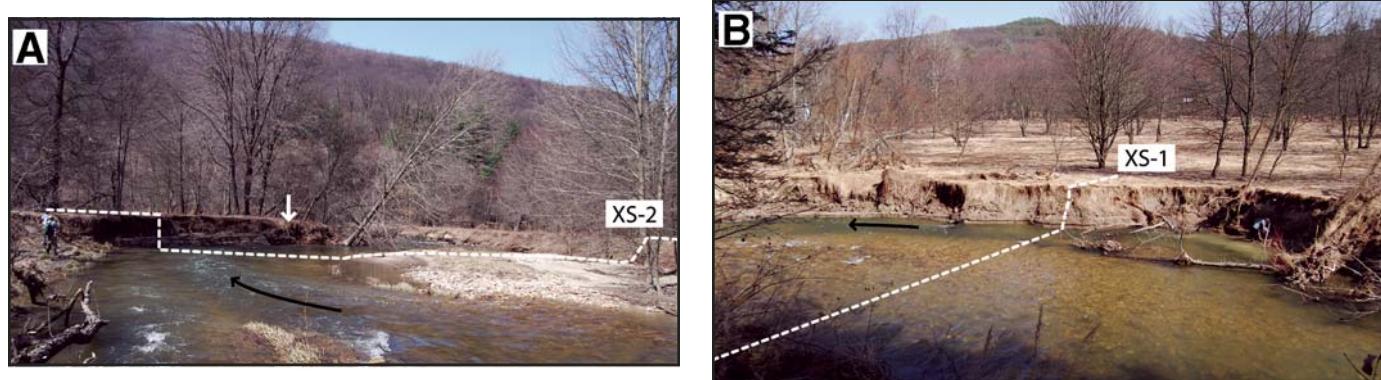
Figure 8. (A) Downstream view of XS-2 at the breached Eaton-Dikeman reservoir on Mountain Creek. Note the point bar on right bank prograding to the left (northwest) within paired fill terraces from the original millpond level. White arrow on left bank indicates exposure of Pleistocene periglacial gravel at base of bank, beneath millpond sediment. This sediment is interpreted as part of a toe-of-slope deposit of South Mountain in the background. (B) View of XS-1 at the breached Eaton-Dikeman reservoir looking across (southeast) the original reservoir surface, toward Piney Mountain in distance. Right bank height is ~3 m at this location, and left bank has eroded into colluvium (periglacial) at the toe of South Mountain (behind and to left of photographer).

nel formed immediately at this breach, and the modern channel gradient is 0.003. State records and photos from 1985 to 1986 indicate that the channel incised and then widened rapidly after dam breaching. Digital ortho-images from 2003 show the incised channel of Mountain Creek 18 yr after dam removal (Fig. 7B), and our photographs of the site show the widened stream corridor 25 yr after dam breaching (Fig. 8).

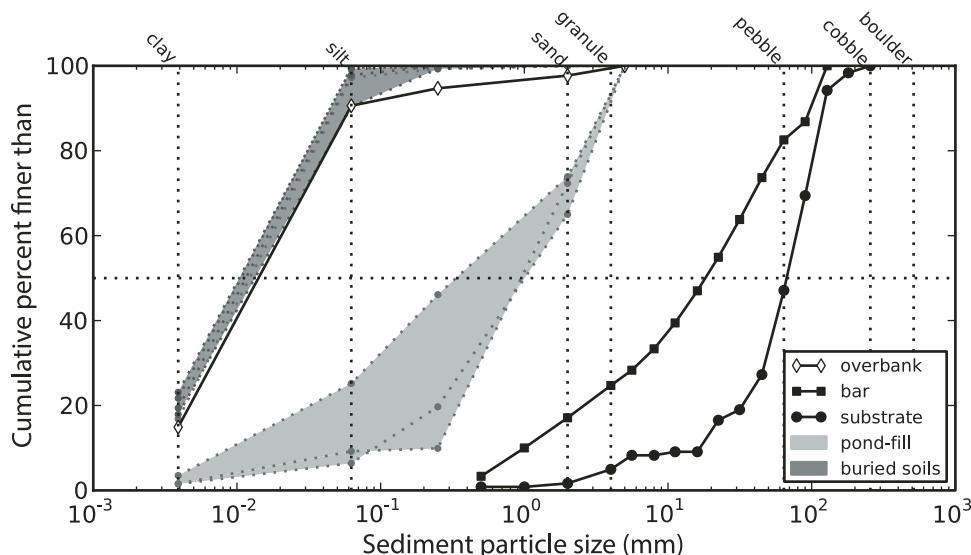
Figure 9. Cumulative grain-size distribution curves for XS-2, with cumulative percent finer on y-axis and grain size on x-axis, for the following sediments: basal gravel substrate exposed in the channel bed by bank erosion, the point bar on right bank, millpond (pond fill) sediment sampled at 10–40-cm-depth increments, and buried fine-grained presettlement sediment between gravel substrate and pond fill. Overbank sediment is uppermost 40 cm of pond fill deposited in shallow pond as overbank deposits (see Fig. 7A).

Particle size data are presented for XS-2 in the Eaton-Dikeman reservoir on Mountain Creek (Fig. 9). Our particle size analysis indicates that grain sizes are similar at XS-1 and XS-2, and field observations indicate they are similar at XS-3, but the historic reservoir sediment is coarser at XS-4, the upstream-most cross section. At XS-2, the historic reservoir sediment consists of 2%–23% clay, 8%–76% silt, and 30%–55% sand, with minor (<1%–25%) amounts of fine gravel. The fine gravel occurs as low-density, porous slag in thin beds with a quartz sand matrix in the uppermost 1 m of reservoir sediment. This slag most likely is from the eighteenth–nineteenth-century Pine Grove and Laurel Forge iron workings located 12 km upstream.

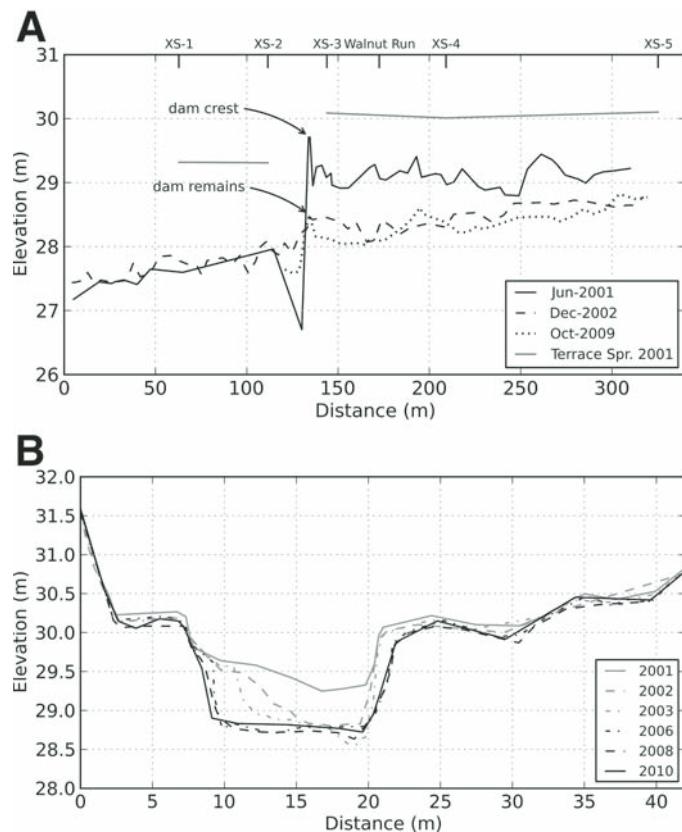
Figure 10. (A) Long profile of Hammer Creek before and after dam breaching. About 0.5 m of the base of the dam remains, forming a grade control that prevents further bed lowering. Terrace surface represents the fill terrace formed by sedimentation to the level of the original dam crest. (B) Repeat surveys of XS-5 showing post-dam-breach vertical incision (2001–2002) followed by channel corridor widening as a result of bank erosion (2002–2010).

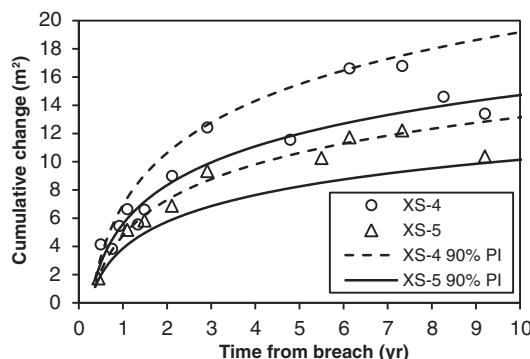
Figure 11. Net channel enlargement of XS-4 and XS-5 at Hammer Creek modeled as a function of the natural log of time. For XS-4,  $n = 13$ ,  $y = 4.48\ln(x) + 5.85$ ,  $R^2 = 0.89$ , and  $p = 1.139 \times 10^{-6}$ , with residuals normally distributed. For XS-5,  $n = 9$ ,  $y = 3.35\ln(x) + 4.72$ ,  $R^2 = 0.94$ , and  $p = 1.826 \times 10^{-5}$ , with residuals normally distributed. The 90% prediction interval (PI) is shown for each cross section and its model. Most channel enlargement is the result of bank erosion and widening, as little vertical change in the bed has occurred since 2002. Instances of recent vertical aggradation at Hammer Creek result from construction, by anglers, of a low rubble dam (~0.5 m height) immediately downstream of the former dam to create a pool for fishing.

the cumulative increase in cross-sectional area is a function of the natural log of time (see Fig. 11A). This increase in channel area is largely an increase in width of the incised stream corridor, as most of the vertical incision occurred soon after dam breaching. Although some bed scour and deposition continue to occur, the 0.5 m of unremoved dam at Hammer Creek and the coarse periglacial substrate beneath historic sediment prevent substantial bed erosion. Similarly, the coarse periglacial substrate at Conoy and Mountain Creeks limits bed degradation (cf. Figs. 8 and 12). For the remaining discussion, we make the assumption that the majority of decadal-scale erosion from the breached millponds studied here is due to lateral bank retreat and that the rate of

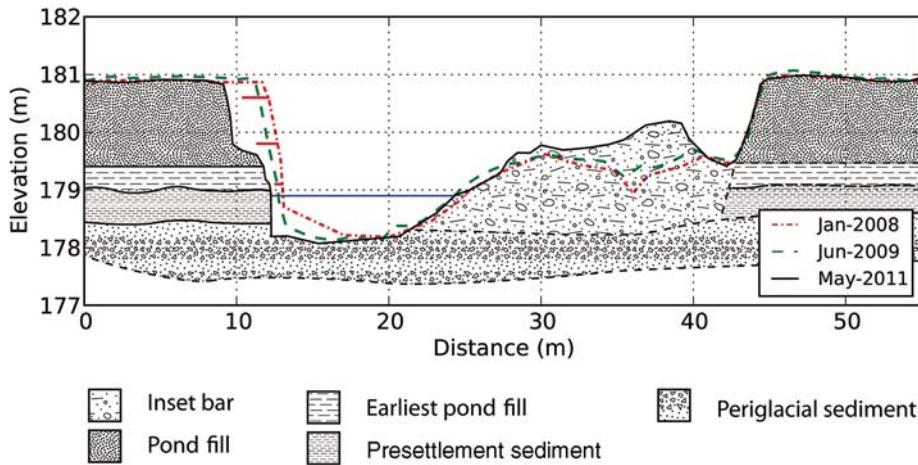
Figure 12. Repeat surveys of channel cross section 2 at Mountain Creek in 2008 (total geodetic station), 2009 (laser level), and 2011 (total geodetic station) reveal erosion of left bank and bar deposition on right bank. Red lines indicate positions of bank pins. Pins are reset periodically to keep pace with erosion. Cumulative erosion of the top pin from 2008 to 2010 was  $>1.6$  m, as the pin was removed during bank erosion in March 2010, and replaced immediately after. Stratigraphic data indicate different age deposits, from Pleistocene periglacial gravel at the base of the section, to fine-grained, organic-rich presettlement sediment, to fine-grained historic millpond sediment, to point-bar sand and gravel

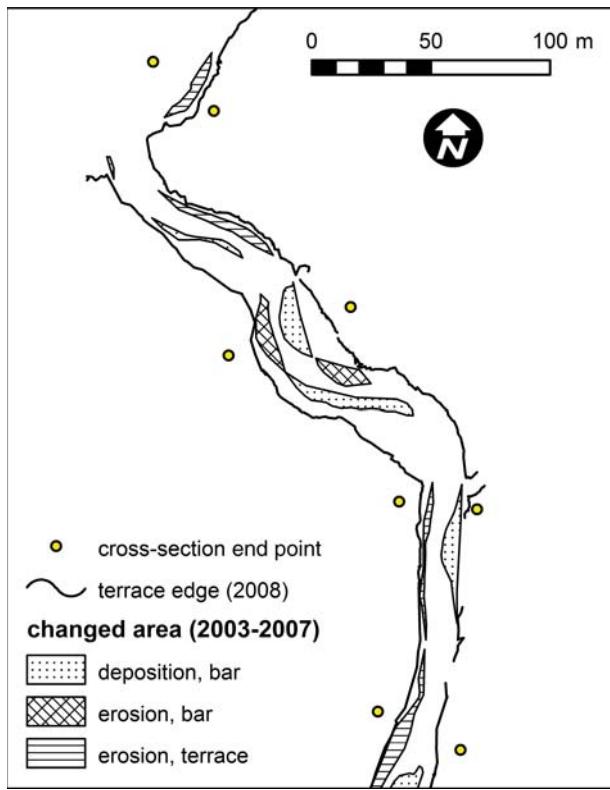
Figure 13. Ortho-images from 2003 and 2006 were mapped and compared with light detection and ranging (LiDAR) elevation data from 2007 and global positioning system (GPS) surveys in 2008 to identify areas of change (erosion and deposition) during the 4 yr interval. Point bars migrated along the channel reach between XS-2 and XS-3 at several meters per year, with upstream tips eroding and downstream tips prograding with time. In addition, incised channel banks eroded laterally, and the stream channel corridor widened with time.

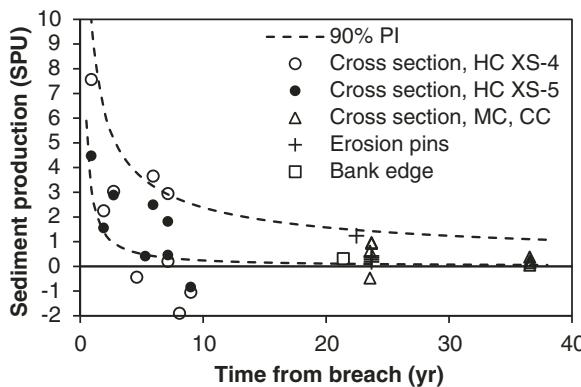
Figure 14. Channel-normalized rate of sediment production from the stream corridor with time is modeled with a negative power function for Hammer and Mountain Creeks. Data sources include channel cross sections for all three breached reservoirs ( $n = 20$ ), and bank pins ( $n = 5$ ) and repeat digital ortho-images ( $n = 1$ ) for Mountain Creek. Each data point represents 1 to 2 yr measurement intervals, with exception of the single data point from repeat digital ortho-images, which represents 3 yr. In some years and at some locations, net change is negative, indicating no change or deposition; however, these values are transient. At Hammer Creek, recent negative values result from construction, by anglers, of a low rubble dam (~0.5 m height) in 2007 and subsequent aggradation in the bed upstream from the dam. We therefore fit a power function to the positive data ( $n = 21$ ) and indicate a 90% prediction interval [PI] for those data. The negative power function indicates that erosion rates slowly diminish with time after an early period of rapid erosion. SPU (sediment production unit): This estimate of sediment produced along a given length of stream channel by stream bank erosion takes into account bank height and erosion rate.

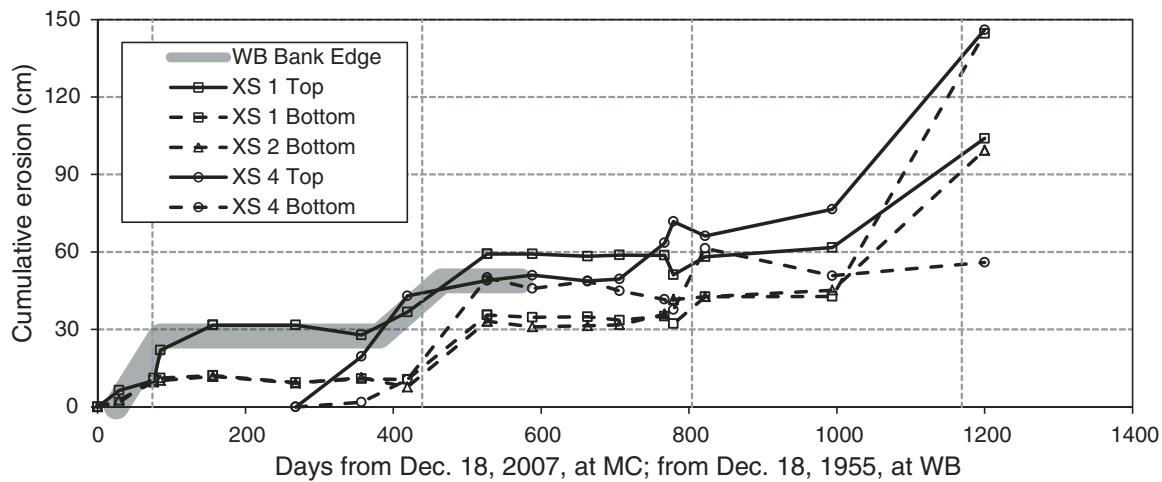
Figure 15. A record of erosion for ~1220 d (3.3 yr) for bank erosion pins at XS-1, XS-2, and XS-4 on Mountain Creek reveals that the majority of bank retreat occurs during mid- to late winter and early spring (December throughout early April). This same phenomenon was observed by Wolman (1959) for Watts Branch (WB), Maryland, also upstream of a breached milldam and in historic reservoir sediment. Watts Branch data from Wolman (1959) are shown as black squares. Wolman collected data from 5 December 1955 to early 1957. For comparison here, the Watts Branch and Mountain Creek (MC) records are plotted versus time since 18 December 2007, the start date for our measurements at XS-1 and XS-2. Pins at the middle of the bank commonly were buried by an apron of debris from above, and were not as frequently swiped clean as the lower bank, and they do not yield as clear a seasonal signal of erosion as top and bottom pins. Vertical lines indicate March 1 for each year.

seasons (Table 2; Fig. 15). The majority of bank retreat occurs in March and April. Similar observations were made by Wolman at Watts Branch in Maryland during the 1950s (Wolman, 1959), and by Lawler in his studies of stream banks in England (cf. Lawler, 1986). Data from Wolman (1959) are plotted here for comparison with our data from Mountain Creek (see Fig. 15). Remarkably, the rates and seasonal timing of bank retreat measured with bank pins and survey lines along the bank edge by Wolman (1959) on Watts Branch, Maryland, are nearly identical to those we measured at Mountain Creek with similar procedures from 2007 to 2010, half a century later. The distance between the two sites is  $\sim 140$  km, with Mountain Creek due north of Watts Branch.

Freeze-thaw processes are significant in weakening the banks of incised streams and are most effective where banks have a large component of silt, as is the case in Mid-Atlantic region millpond reservoirs. Lawler (1986) determined that bank erosion rates from freeze-thaw processes are proportional to the number of days with air frost (air temperature  $\leq 0.0$  °C). Furthermore, bank erosion rate corresponds more strongly with this parameter than any of the other 16 meteorological and hydrologic variables examined for the Ilston River by Lawler (1986). For southeastern Pennsylvania, air temperature dropped below 0 °C at least 100 d in both 2008 and 2009. Lawler's statistical regression equation for erosion rate as a response to number of days of frost (see Table IV in Lawler, 1986) yields a predicted value of bank erosion of 0.6 m/yr, similar to rates measured at the sites discussed here, including Watts Branch, Maryland (see Fig. 15).
