What Lies Beneath:
The Geological and Environmental Transition from
Holocene Wetlands to Historic Legacy Sediments

...and How This Informs Restoration

2026 PA Aquatic Resource Restoration Conference
March 3, 2026

Robert Walter, Dorothy Merritts, Chris Williams, Adam Benfield, Julia Carr, Shuyu Chang,
Joe Galella, Jake Lamb, Mike Rahnis, Department of Earth and Environment

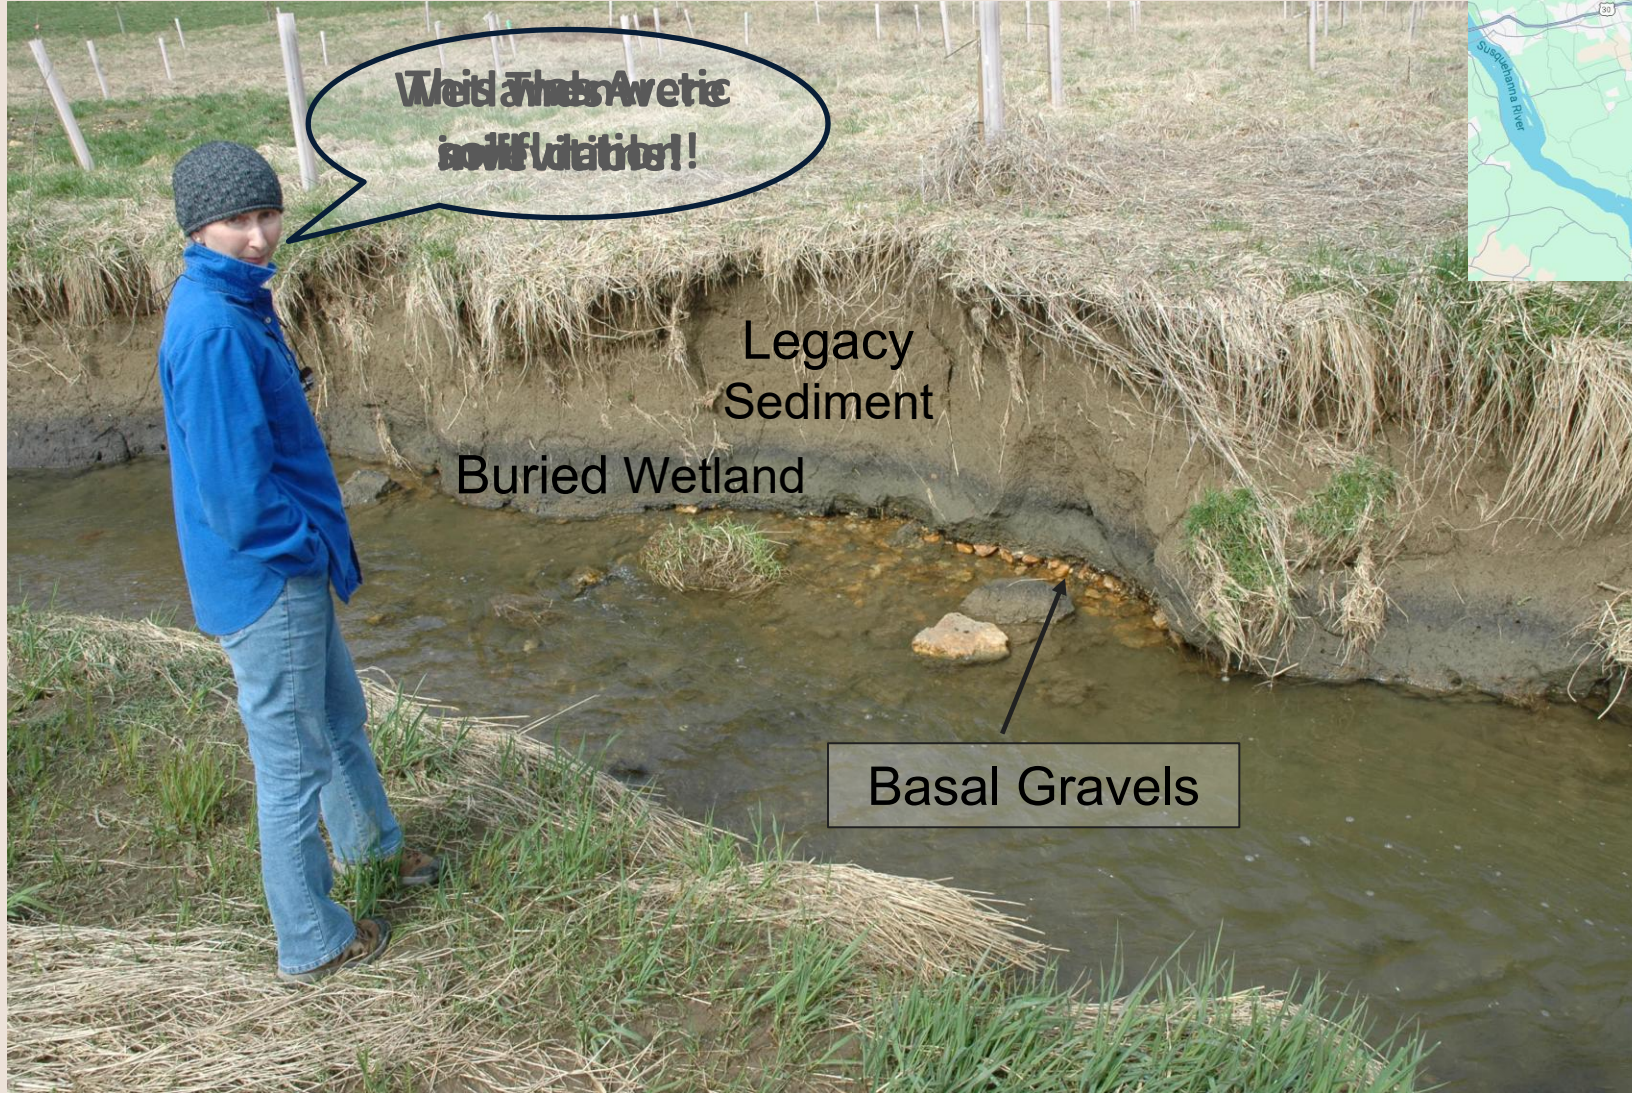
Big Spring Run, Lancaster Co (4/8/05)

I. Stream Bank Stratigraphy

2 m

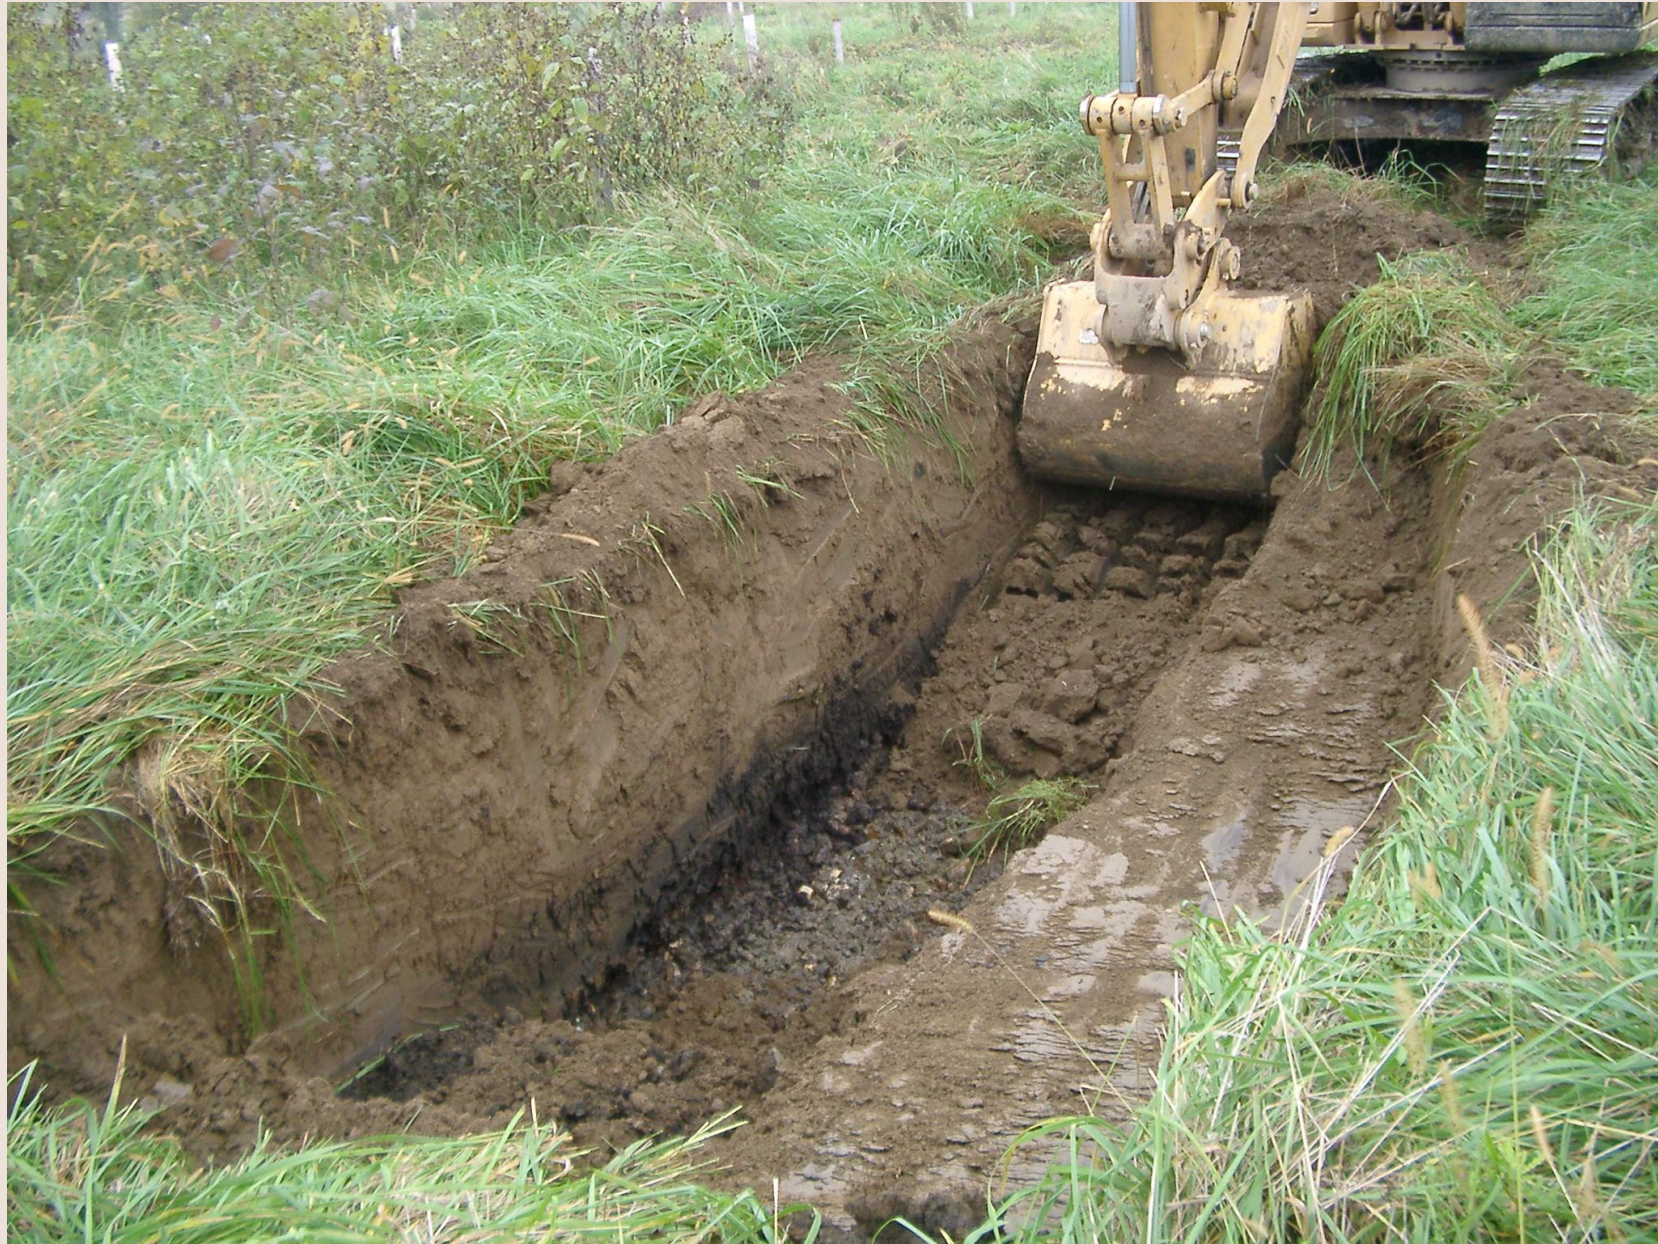
Big Spring Run, Lancaster Co. 10/15/04 (LandStudies)

II. Trenching

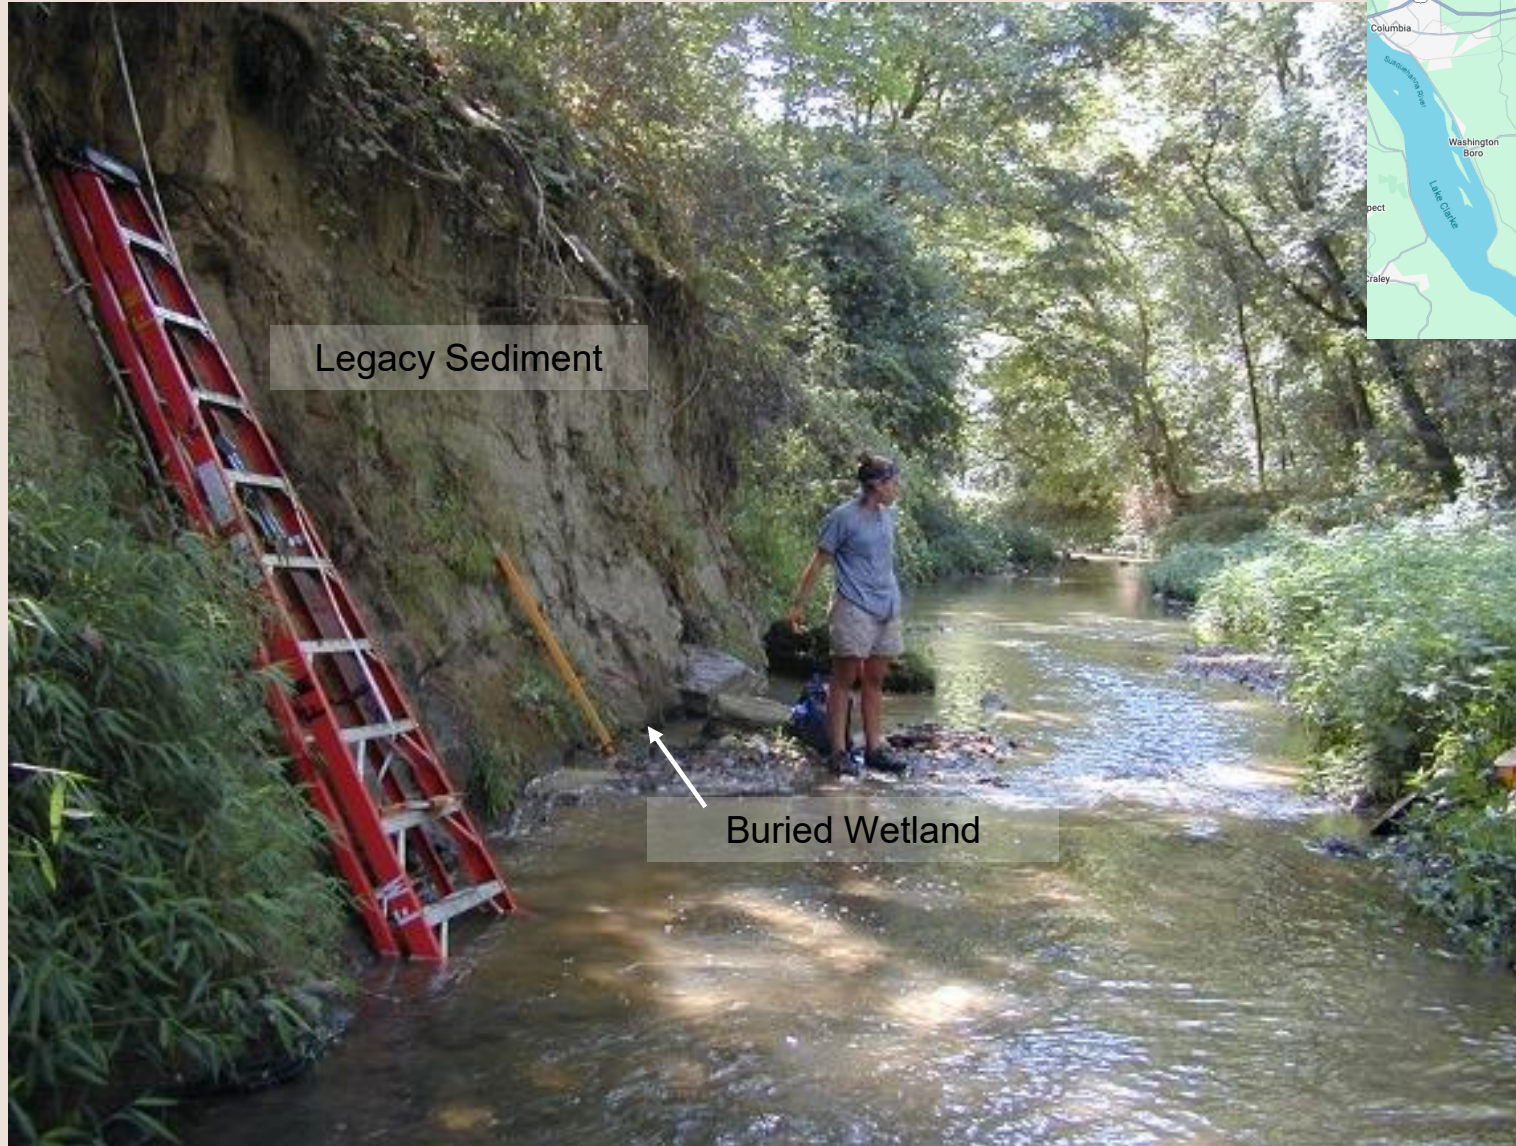
Denlingers Mill, West Branch Little Conestoga, Lancaster Co. (6/6/03)

Stream Bank Stratigraphy

Legacy Sediment

Buried Wetland

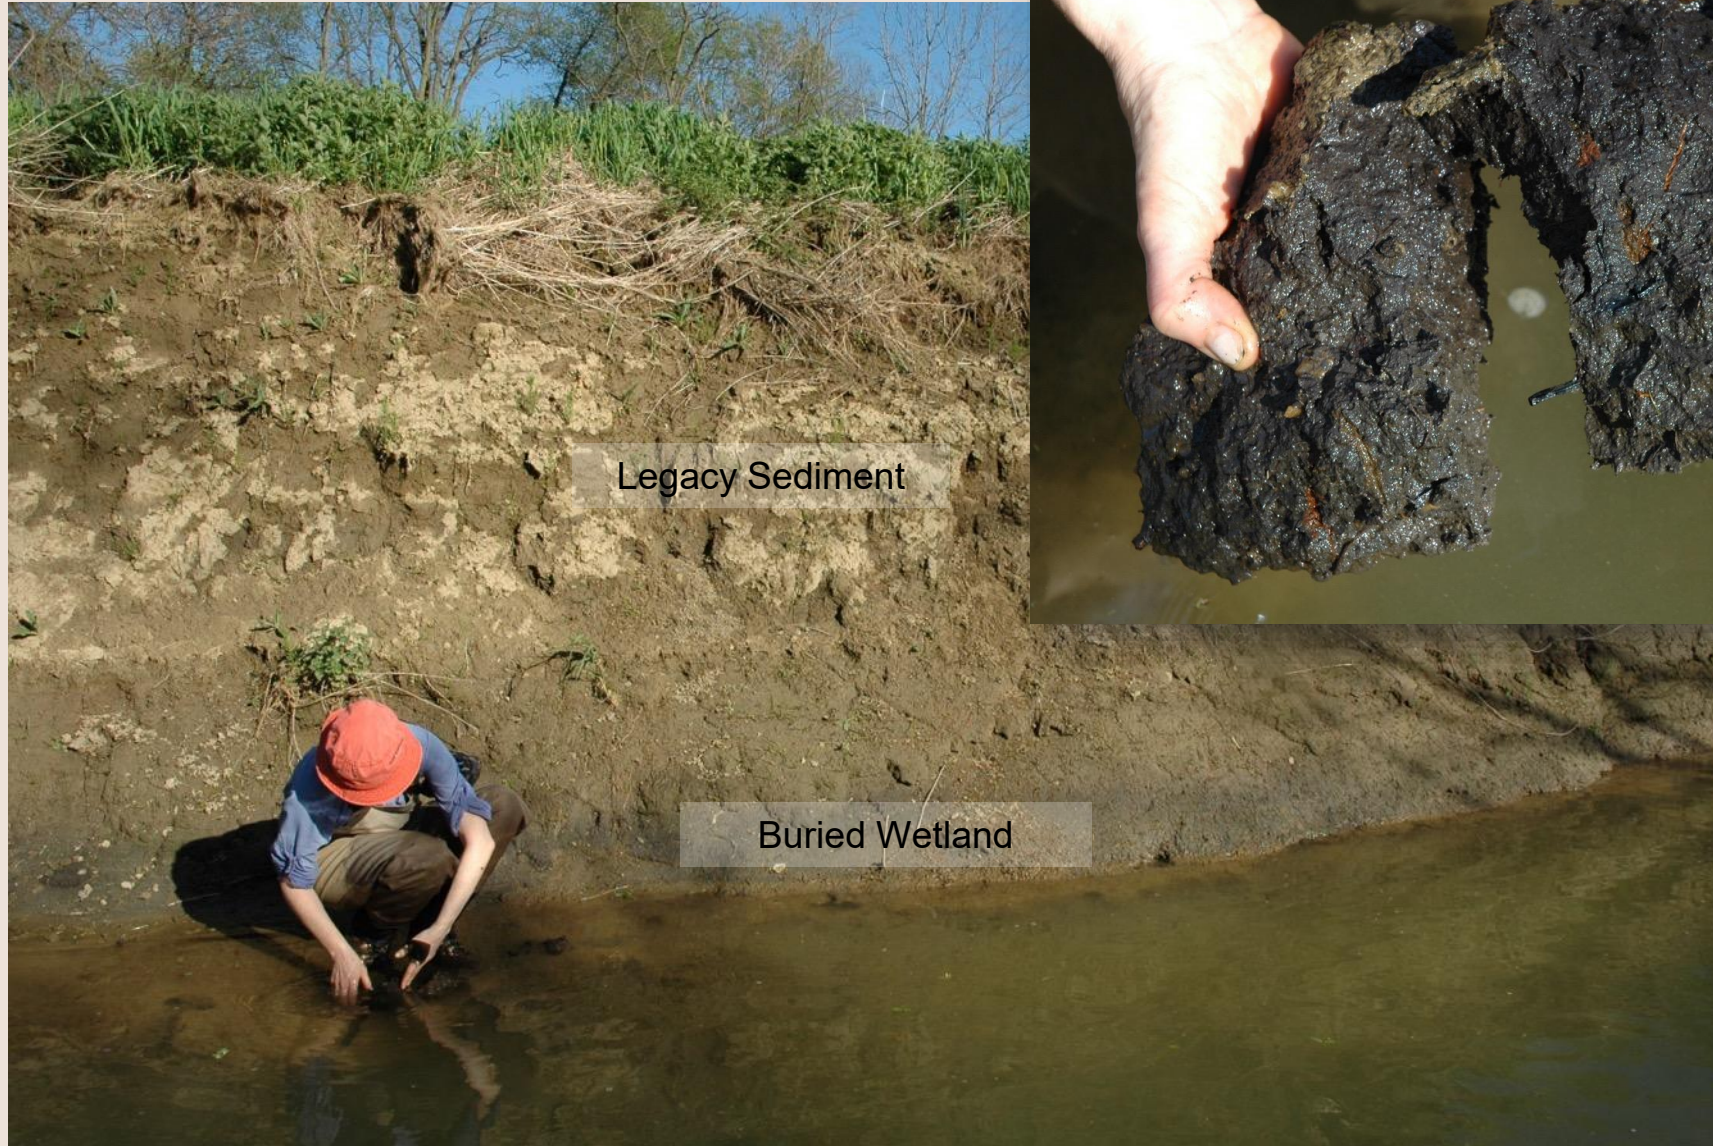
Benders Mill, West Branch Little Conestoga Creek, Lancaster Co. (4/30/07)

Stream Bank Stratigraphy

Buried wetlands are everywhere!

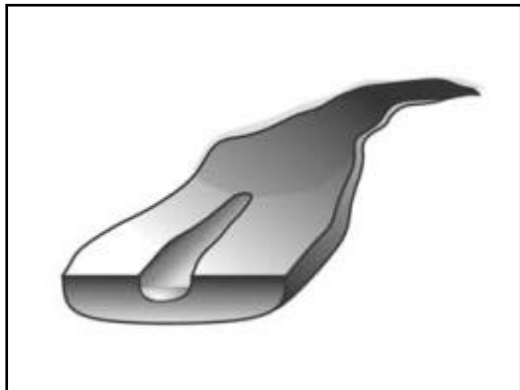
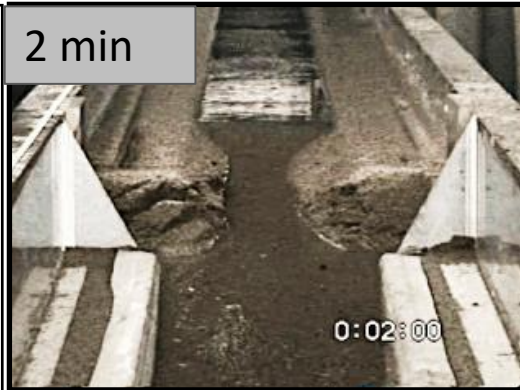
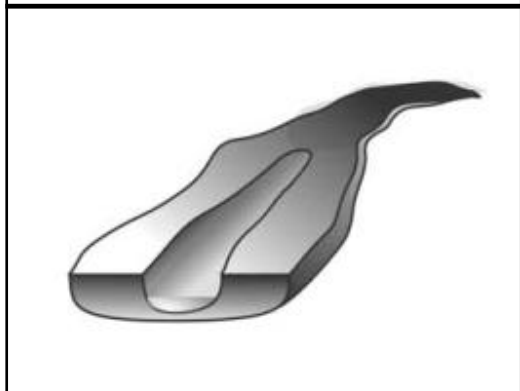
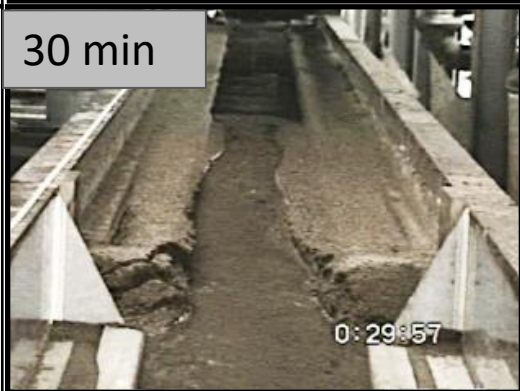
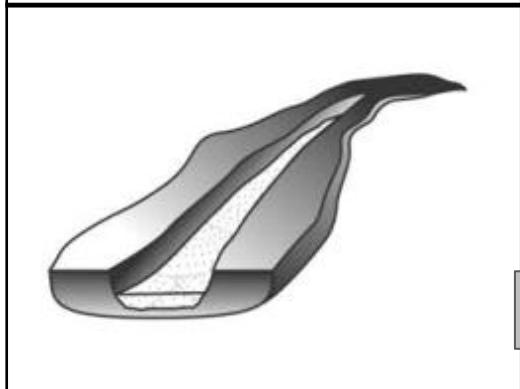
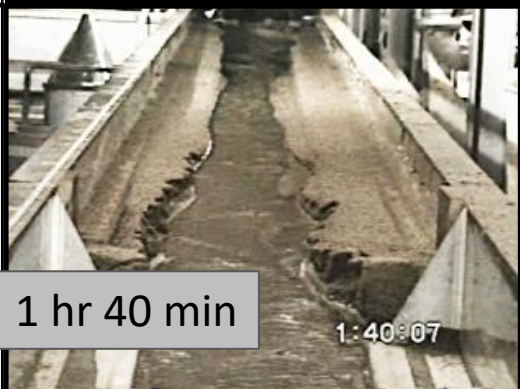
Laboratory Dam Failure

**Physical
(Cantelli, 2009)**

Flume experiments and video footage from
Dr. Allesandro Cantelli, University of Minnesota

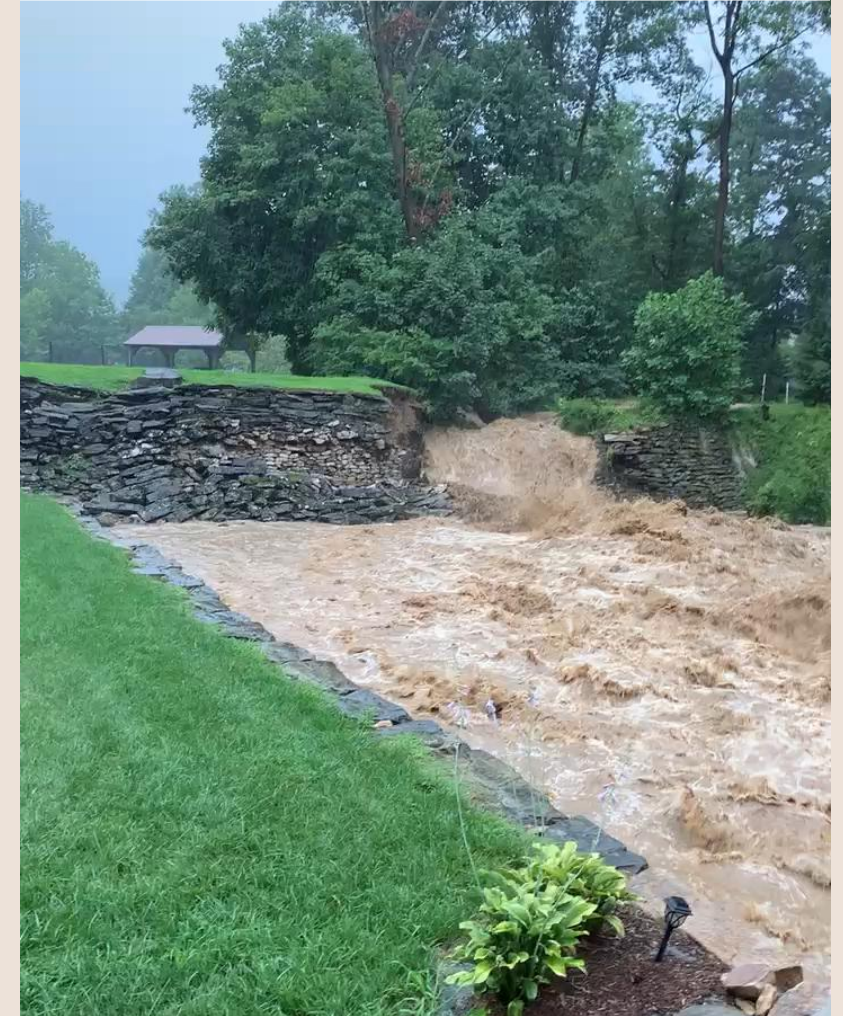
Natural Dam Failure Sides Mill

Realtime footage, 2020, from
the Hess Family, Strasburg, PA

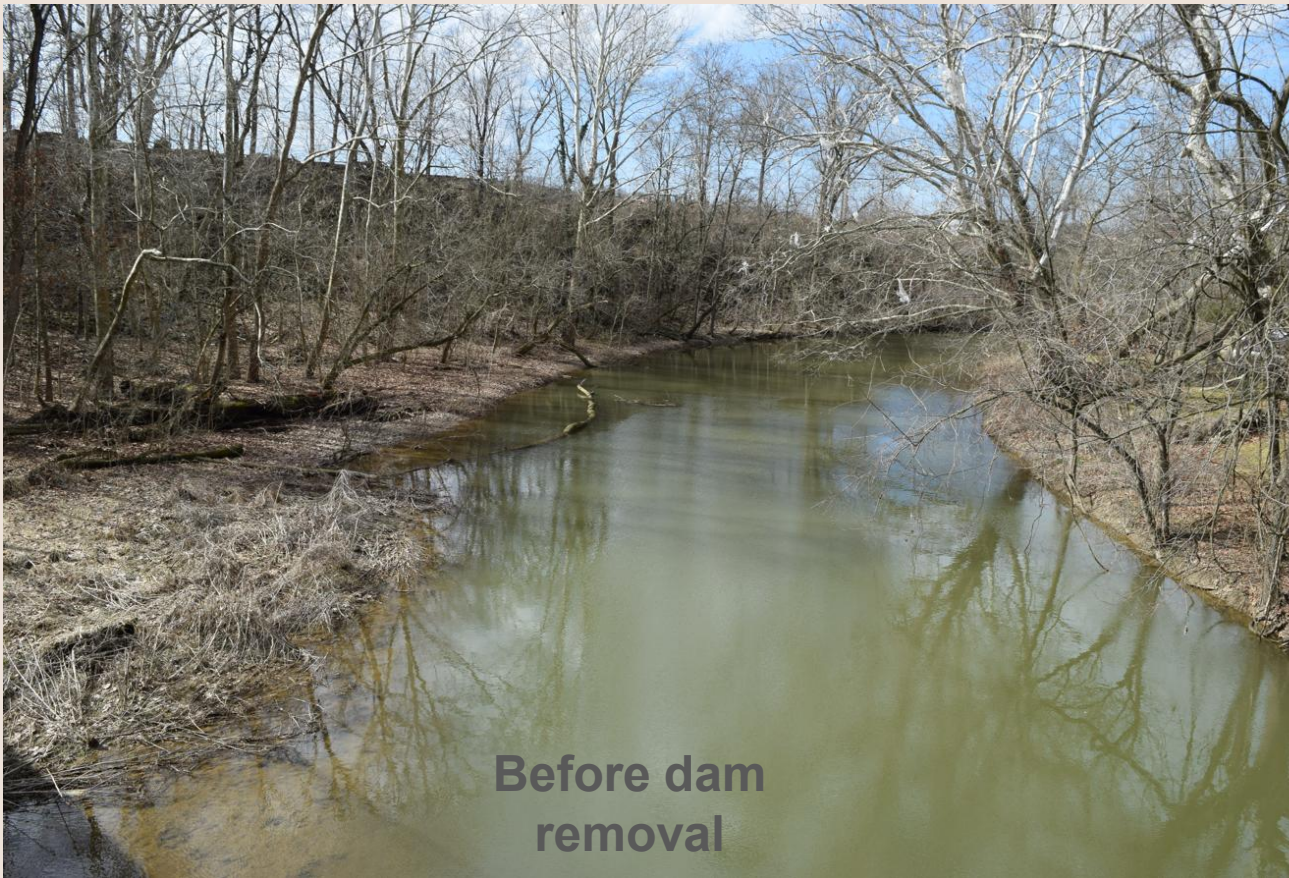
Before dam
removal

View ~800 ft Upstream of Krady milldam

Feb 21, 2018

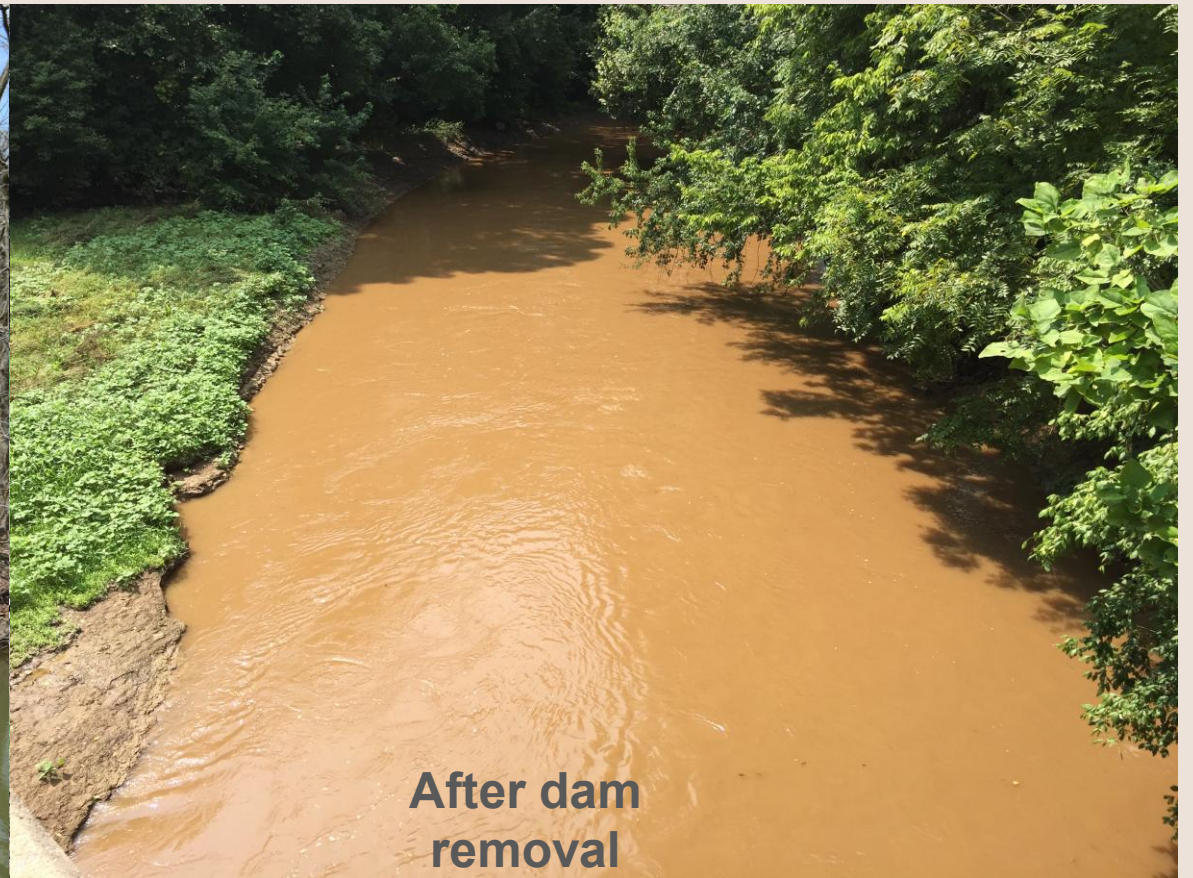
After dam
removal

Dam Removal
July 8, 2018

August, 2018

Roughly **2450 tons** of reservoir sediment erosion was measured along an 800 ft length of stream, within weeks after dam removal.

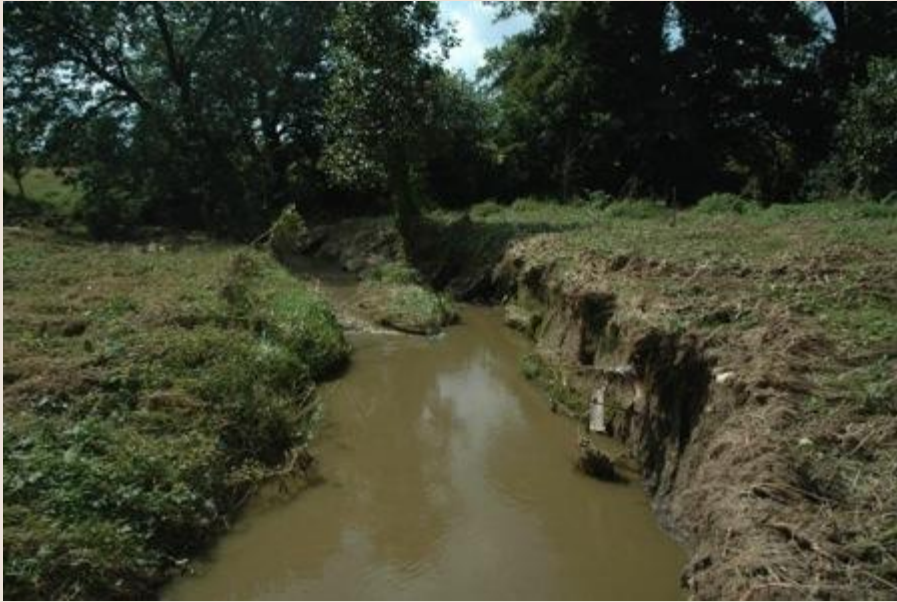
Before Restoration 9/13/11

Big Spring Run Site 1

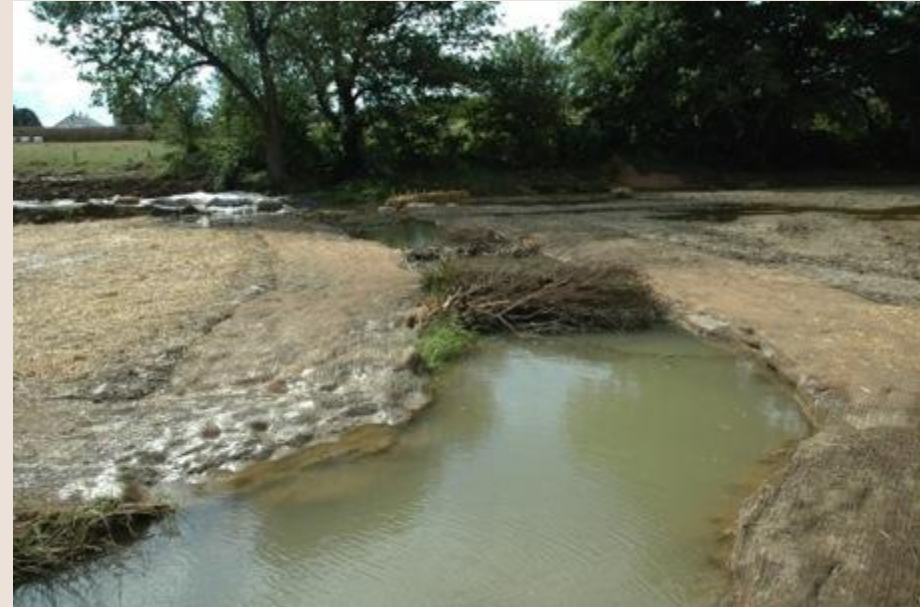
After Restoration 9/28/11

Objective 1: Reconnect the groundwater and surface water with a low, hydric floodplain

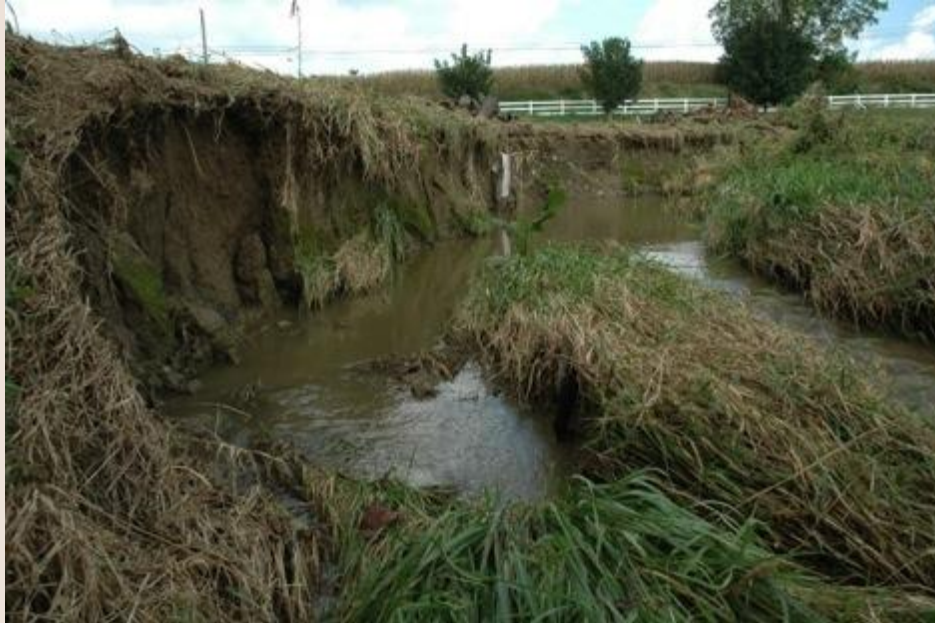
Before Restoration 9/13/11

Big Spring Run Site 1

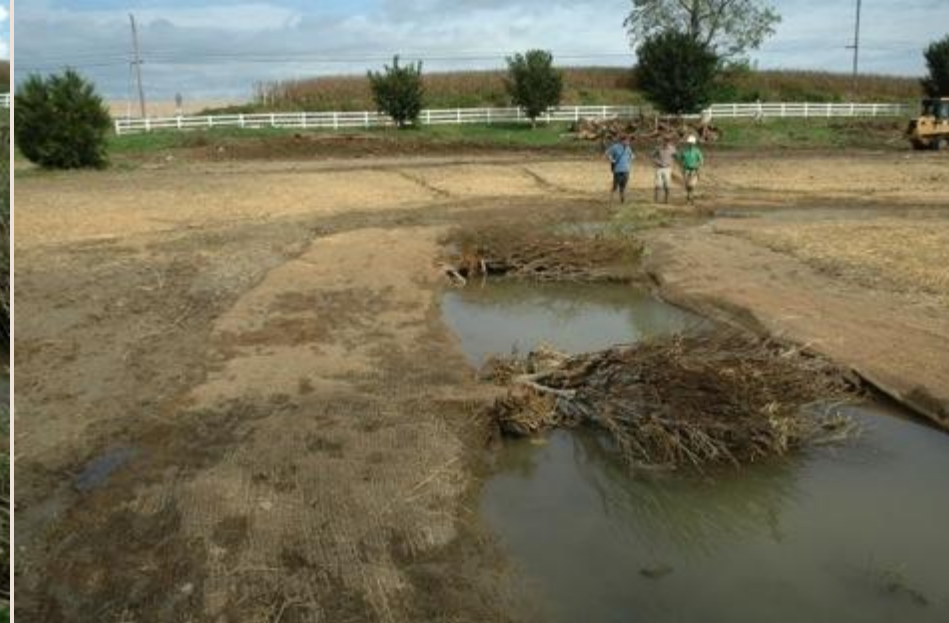
After Restoration 9/28/11

Objective 2: Remove the impairment... the eroding stream banks that contribute to high suspended sediment and nutrient loads (see my talk with Justin Spangler at 12:35 PM today).

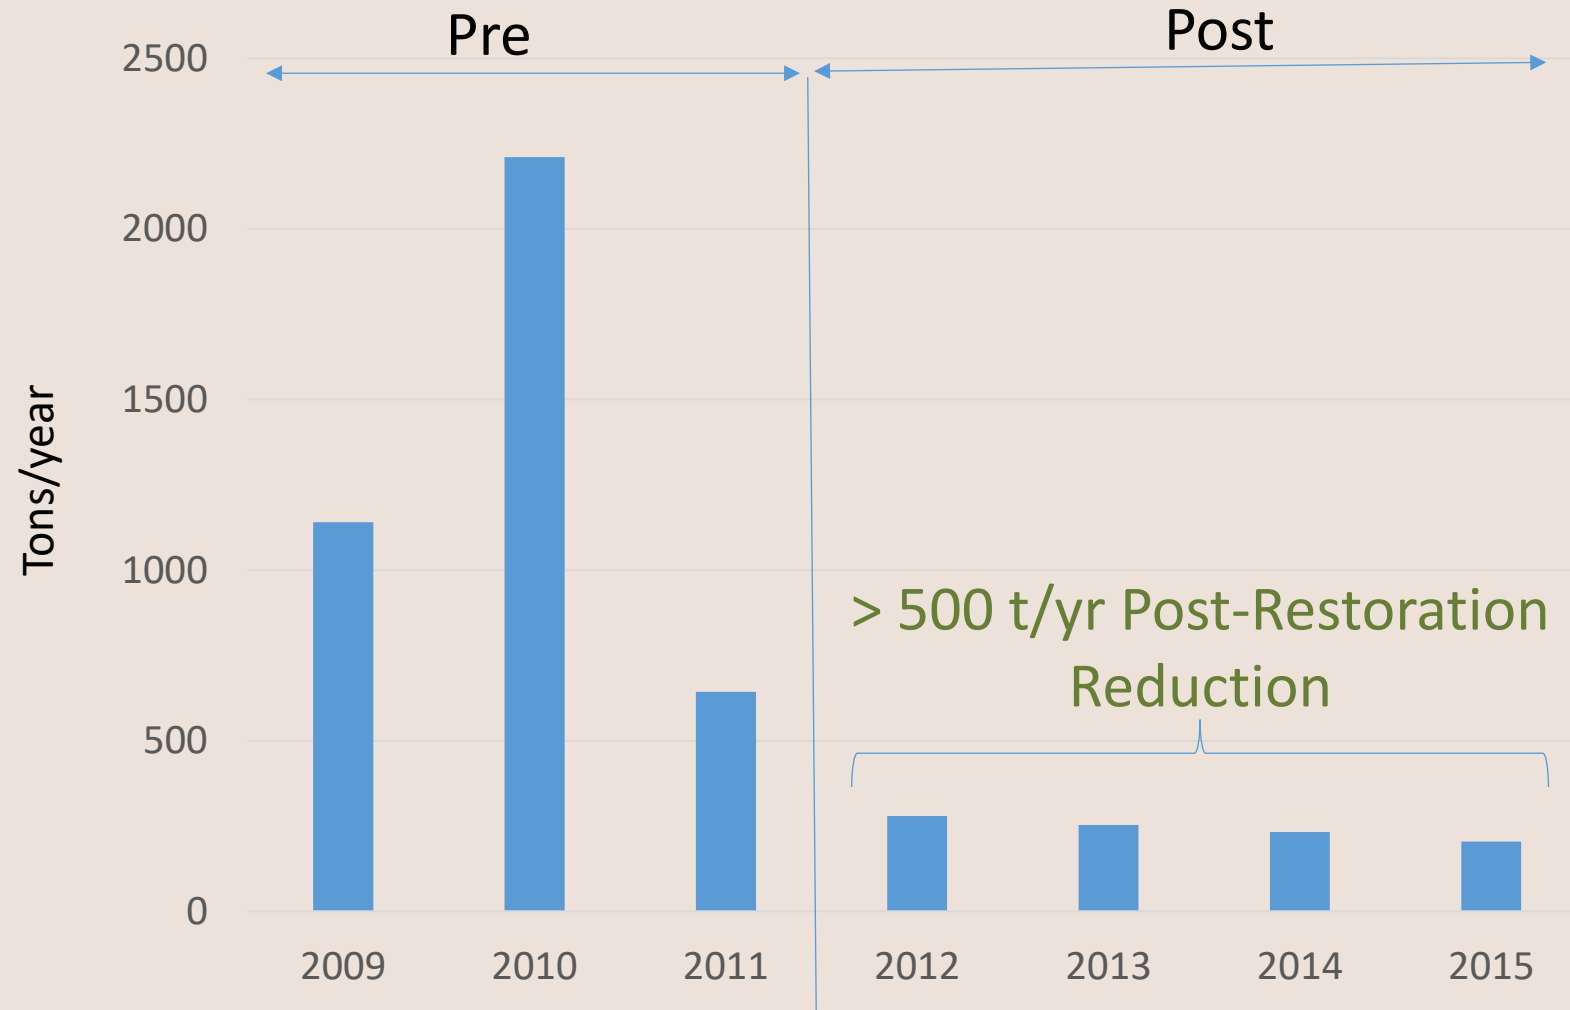
i. Annual Suspended Sediment Loads - 2008 to 2015 water years

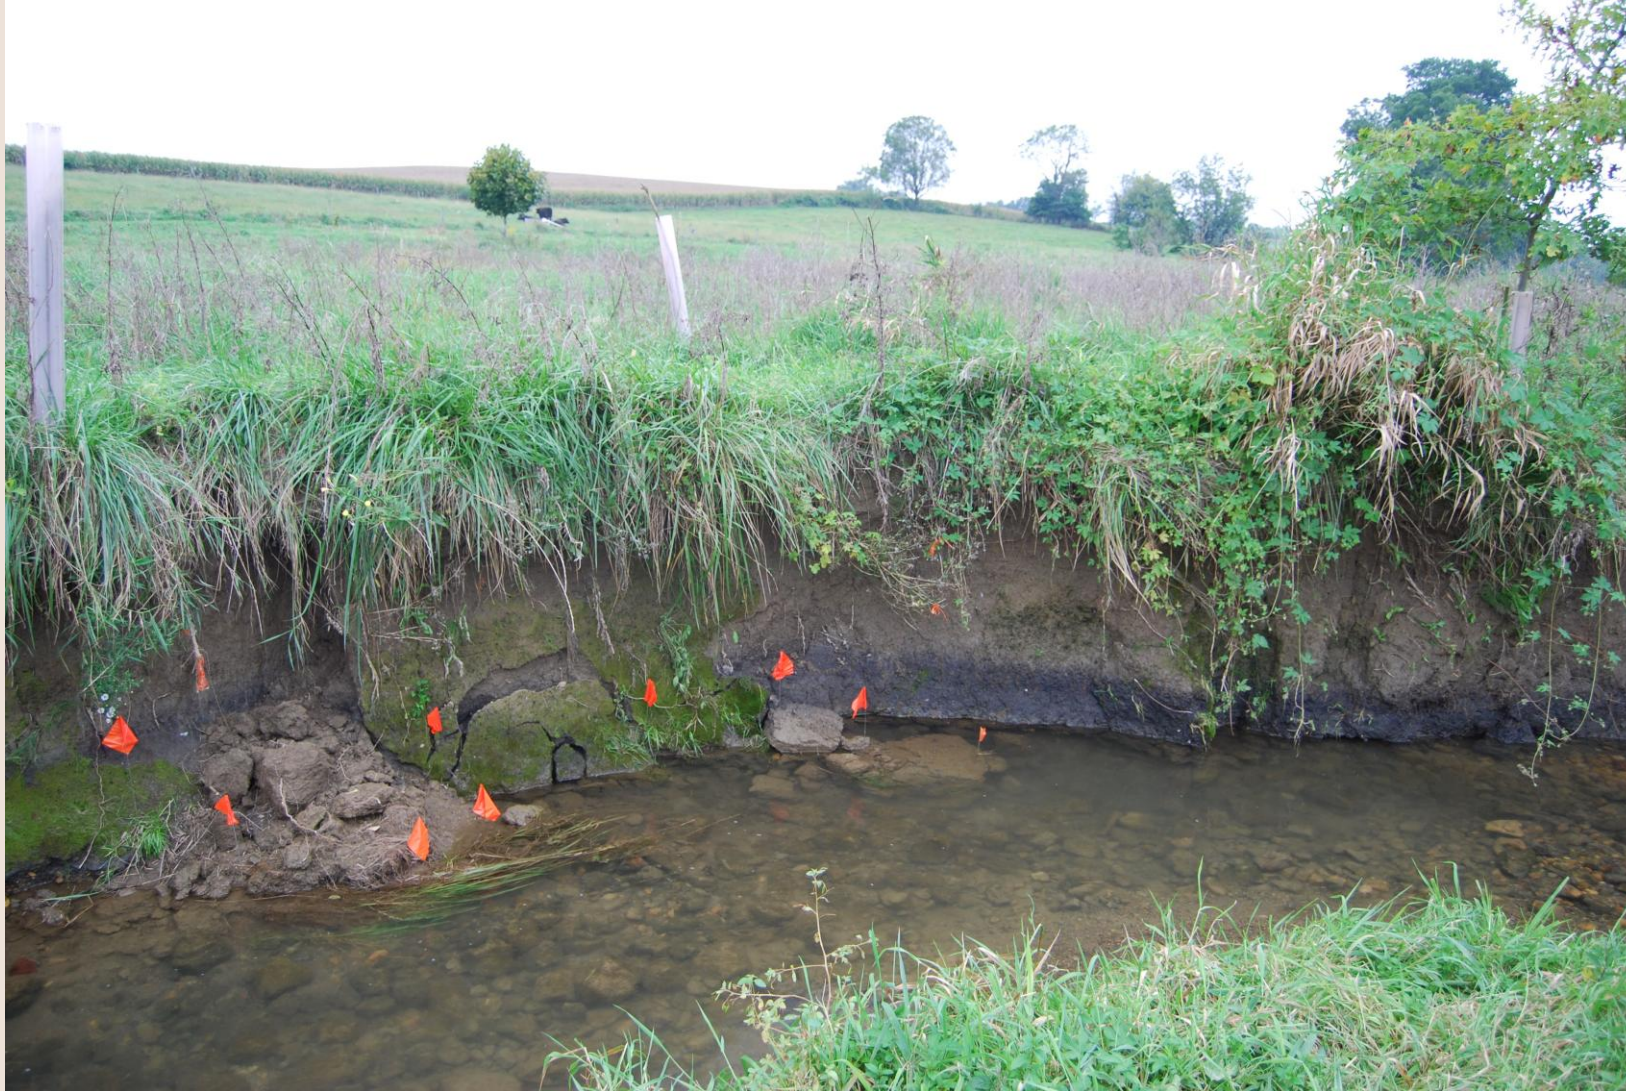
Big Spring Run 9/16/09

Sources of Bank Erosion - After Summer Storm Events

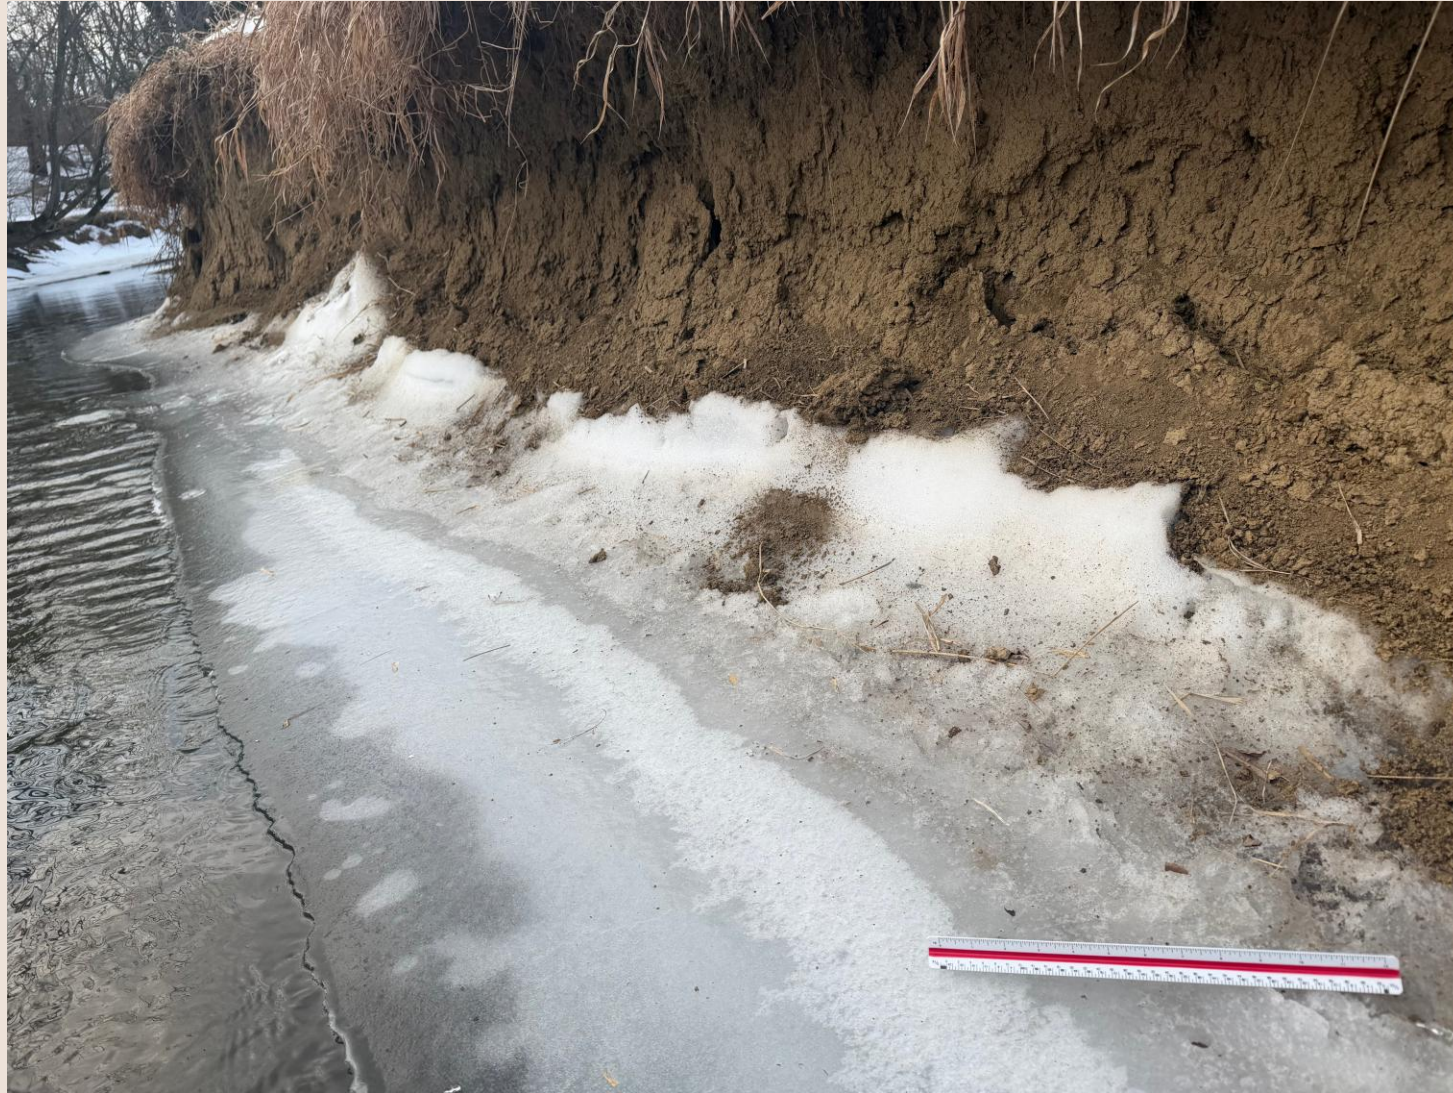
Little Conestoga Creek - Woodcrest Villa 2/12/26

Sources of Bank Erosion - Needle Ice and Freeze Thaw Processes

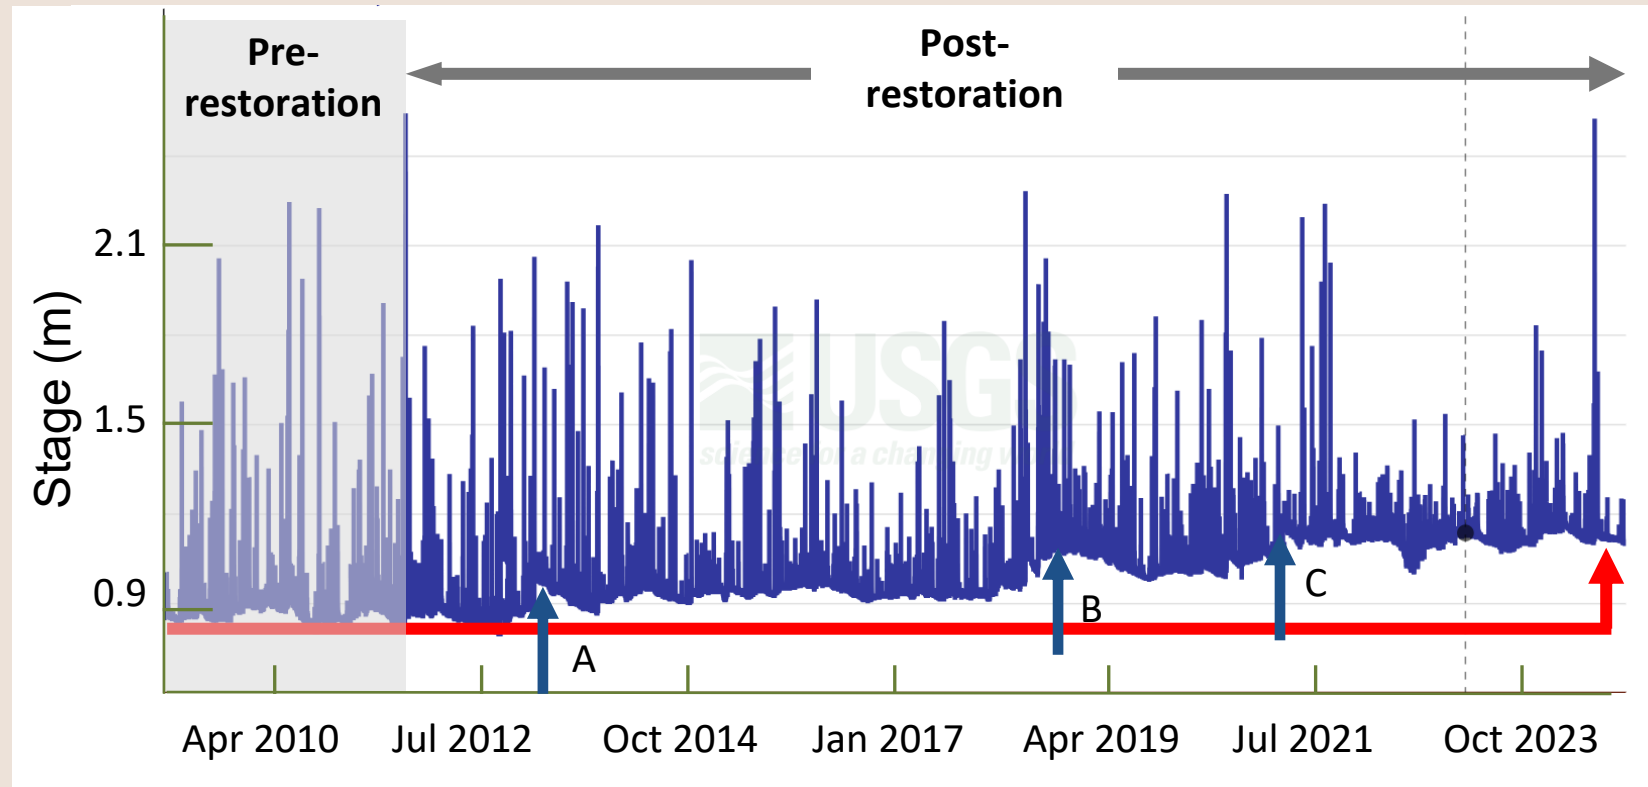
- Substantial, sustained jumps in base flow occur in (A) August 2012, (B) March 2017, and (C) June 2021.
- Base flow stage increased by 30 cm from 2012-2024.
- Consistent with groundwater recharge and greater hyporheic exchange.

USGS continuous gage station at downstream end of BSR restoration 2008-present (>16 years).

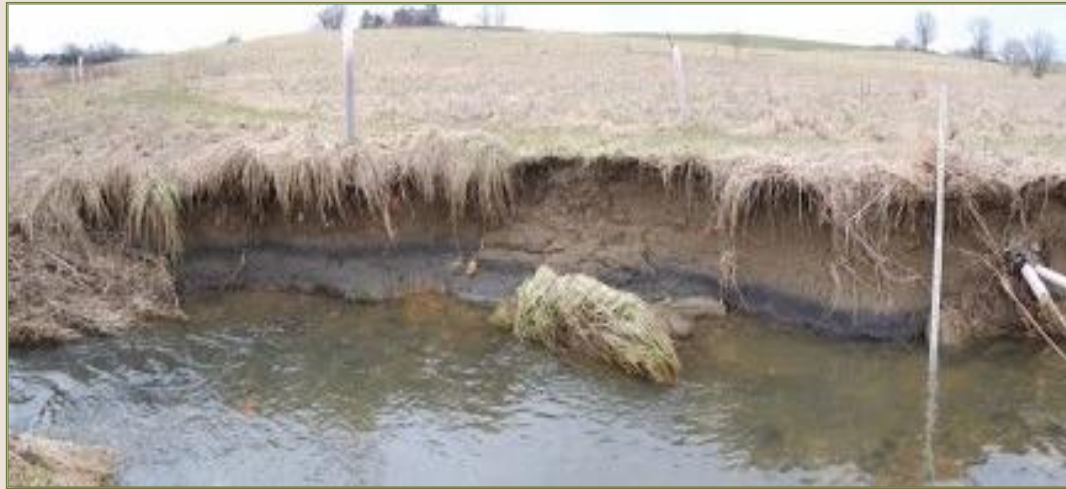
Pre-restoration condition

Degraded hydrology
Less plant biomass
More soil CO₂ emission
Lower C sequestration
Less stable carbon

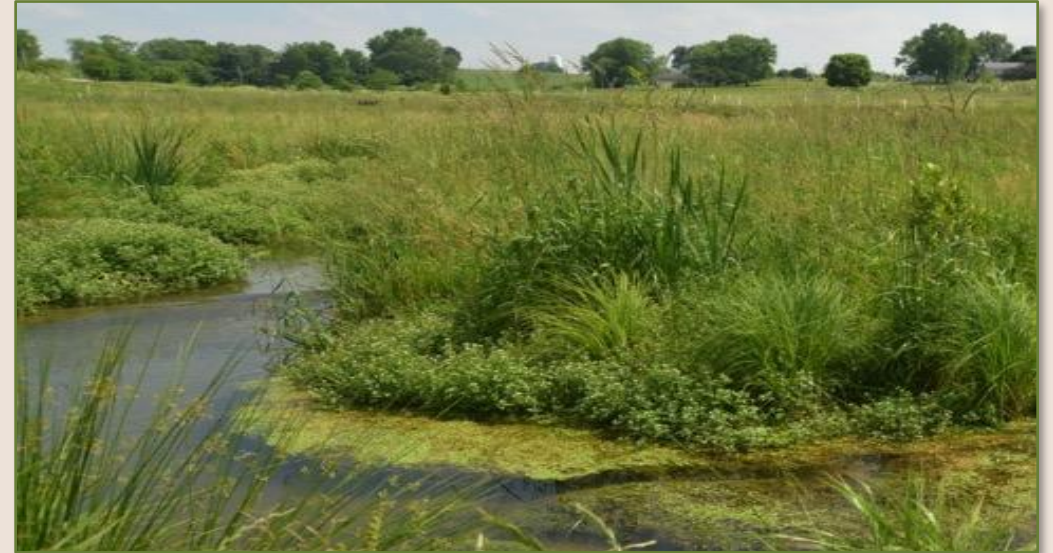
Post-restoration condition

Restored hydrology
More plant biomass
Less soil CO₂ emission
Enhanced C sequestration
More stable carbon
