What Lies Beneath:
The Geological and Environmental Transition from
Holocene Wetlands to Historic Legacy Sediments

...and How This Informs Restoration

2026 PA Aquatic Resource Restoration Conference
March 3, 2026

Robert Walter, Dorothy Merritts, Chris Williams, Adam Benfield, Julia Carr, Shuyu Chang,
Joe Galella, Jake Lamb, Mike Rahnis, Department of Earth and Environment

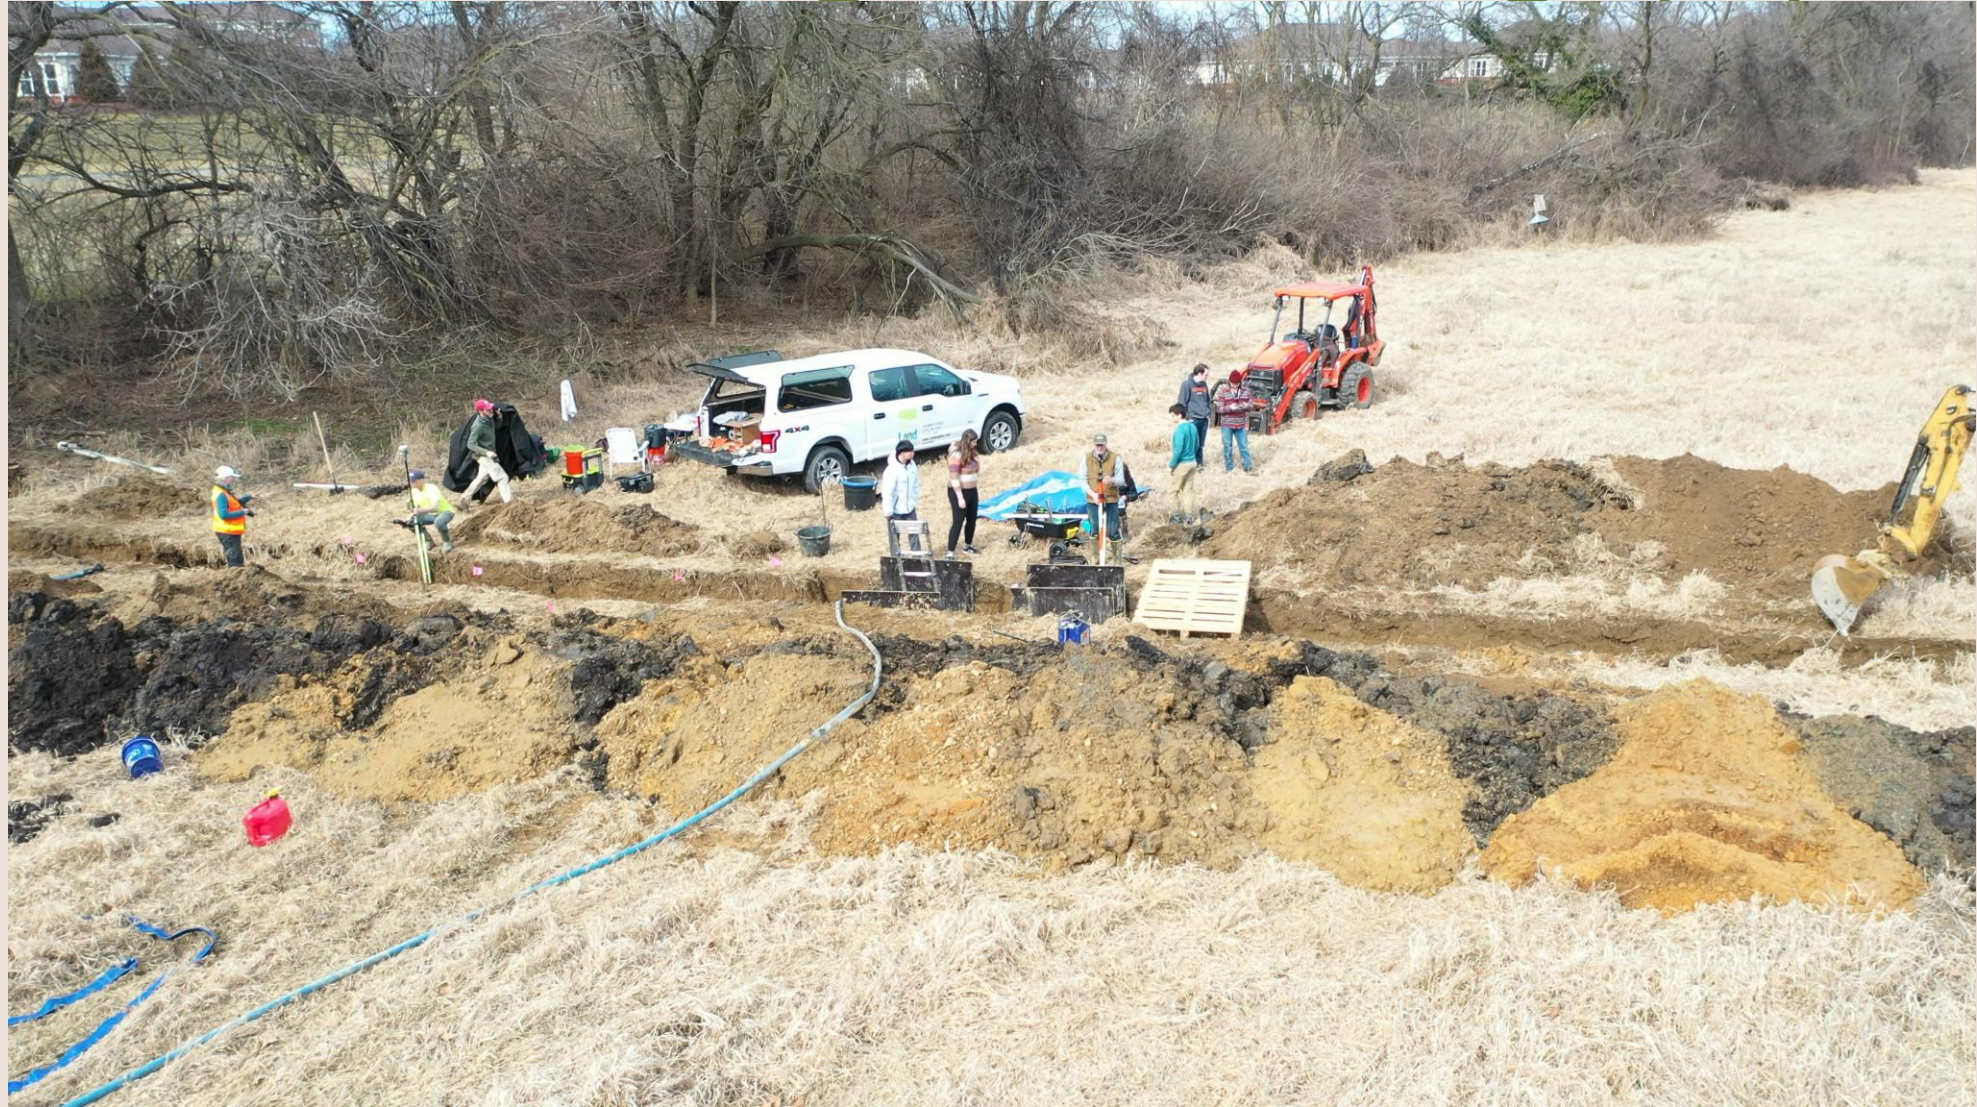
Woodcrest Villa Trench 2/13/23

Little Conestoga Creek Stratigraphy
