CHESAPEAKE WATERSHED INITIATIVE

Stratigraphic Investigation Techniques

2026 PA Aquatic Resource Restoration Conference

Robert Walter, Justin Spangler (LandStudies), Dorothy Merritts, and Mike Rahnis
Departments of Earth and Environment

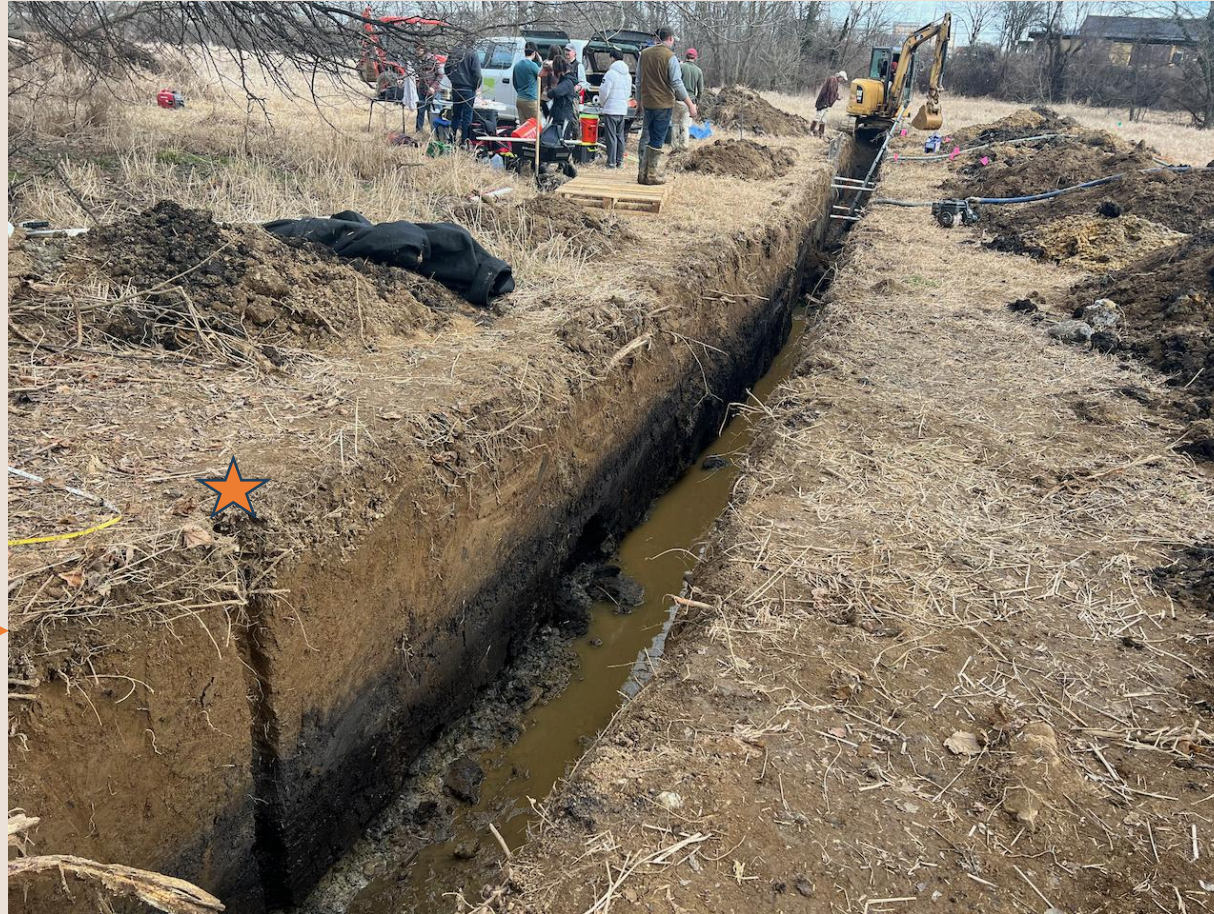
LCC-Woodcrest Villa Valley Bottom Photography

Lindsay Silt-Loam (Ln) →

★ Woodcrest Villa Stratigraphic Section

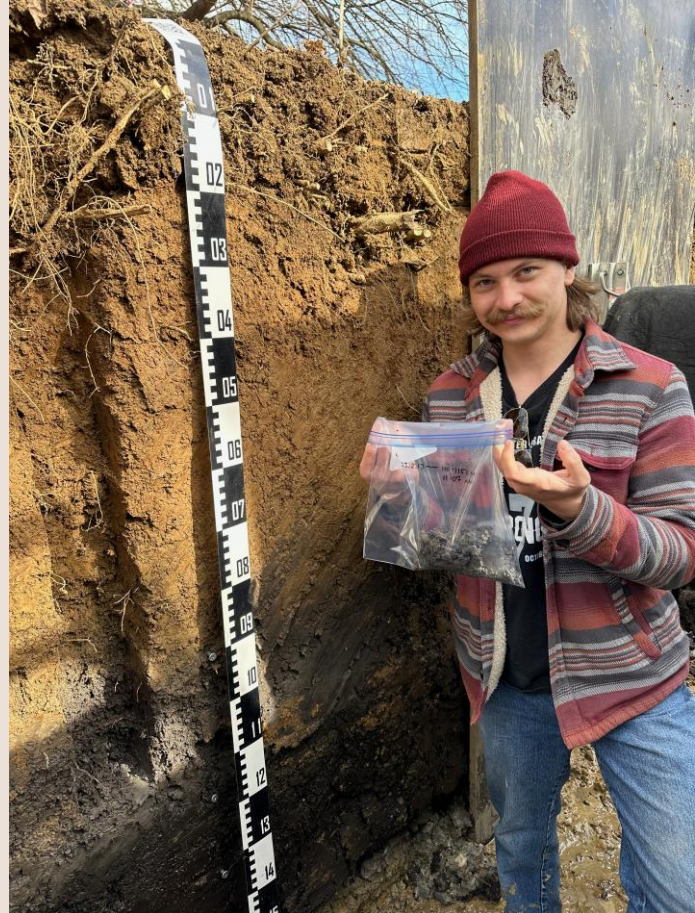
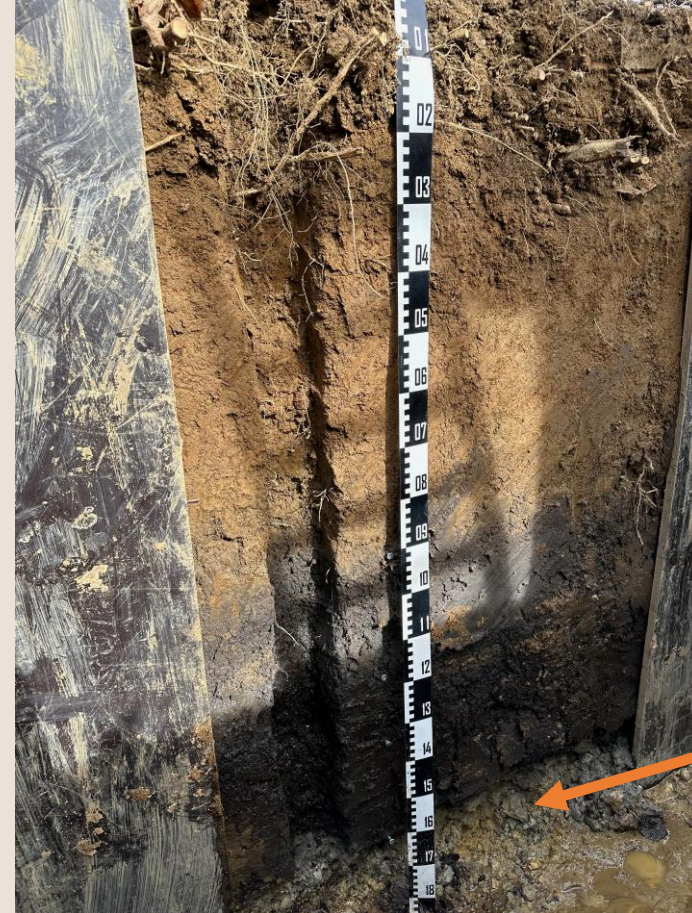
LCC-Woodcrest Villa Valley Bottom Photography

Legacy Sediments →

Buried Wetland →

Basal Gravels

Woodcrest Villa Stratigraphic Section

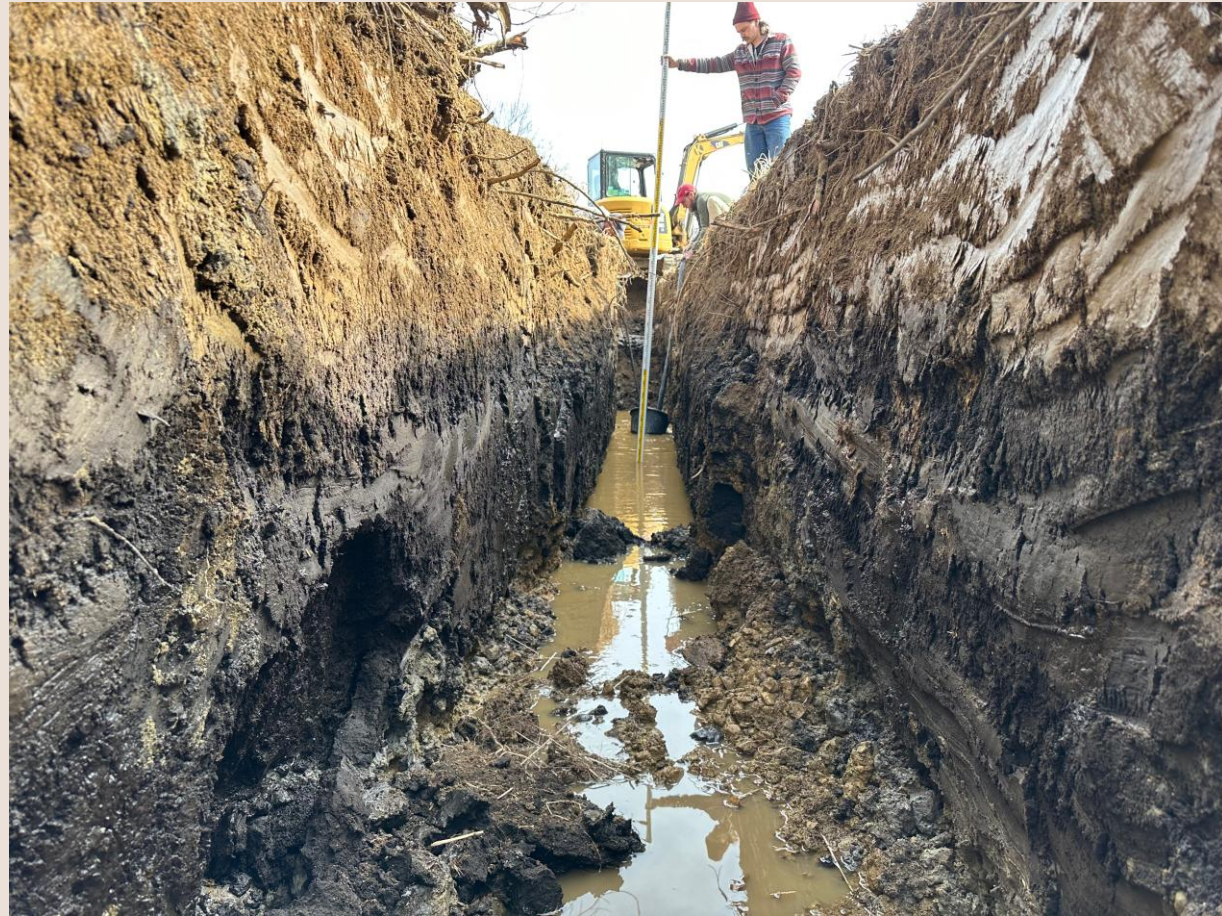
LCC-Woodcrest Villa Valley Bottom Photography

Legacy Sediments →

Buried Wetland →

Basal Gravels →

Woodcrest Villa Stratigraphic Section

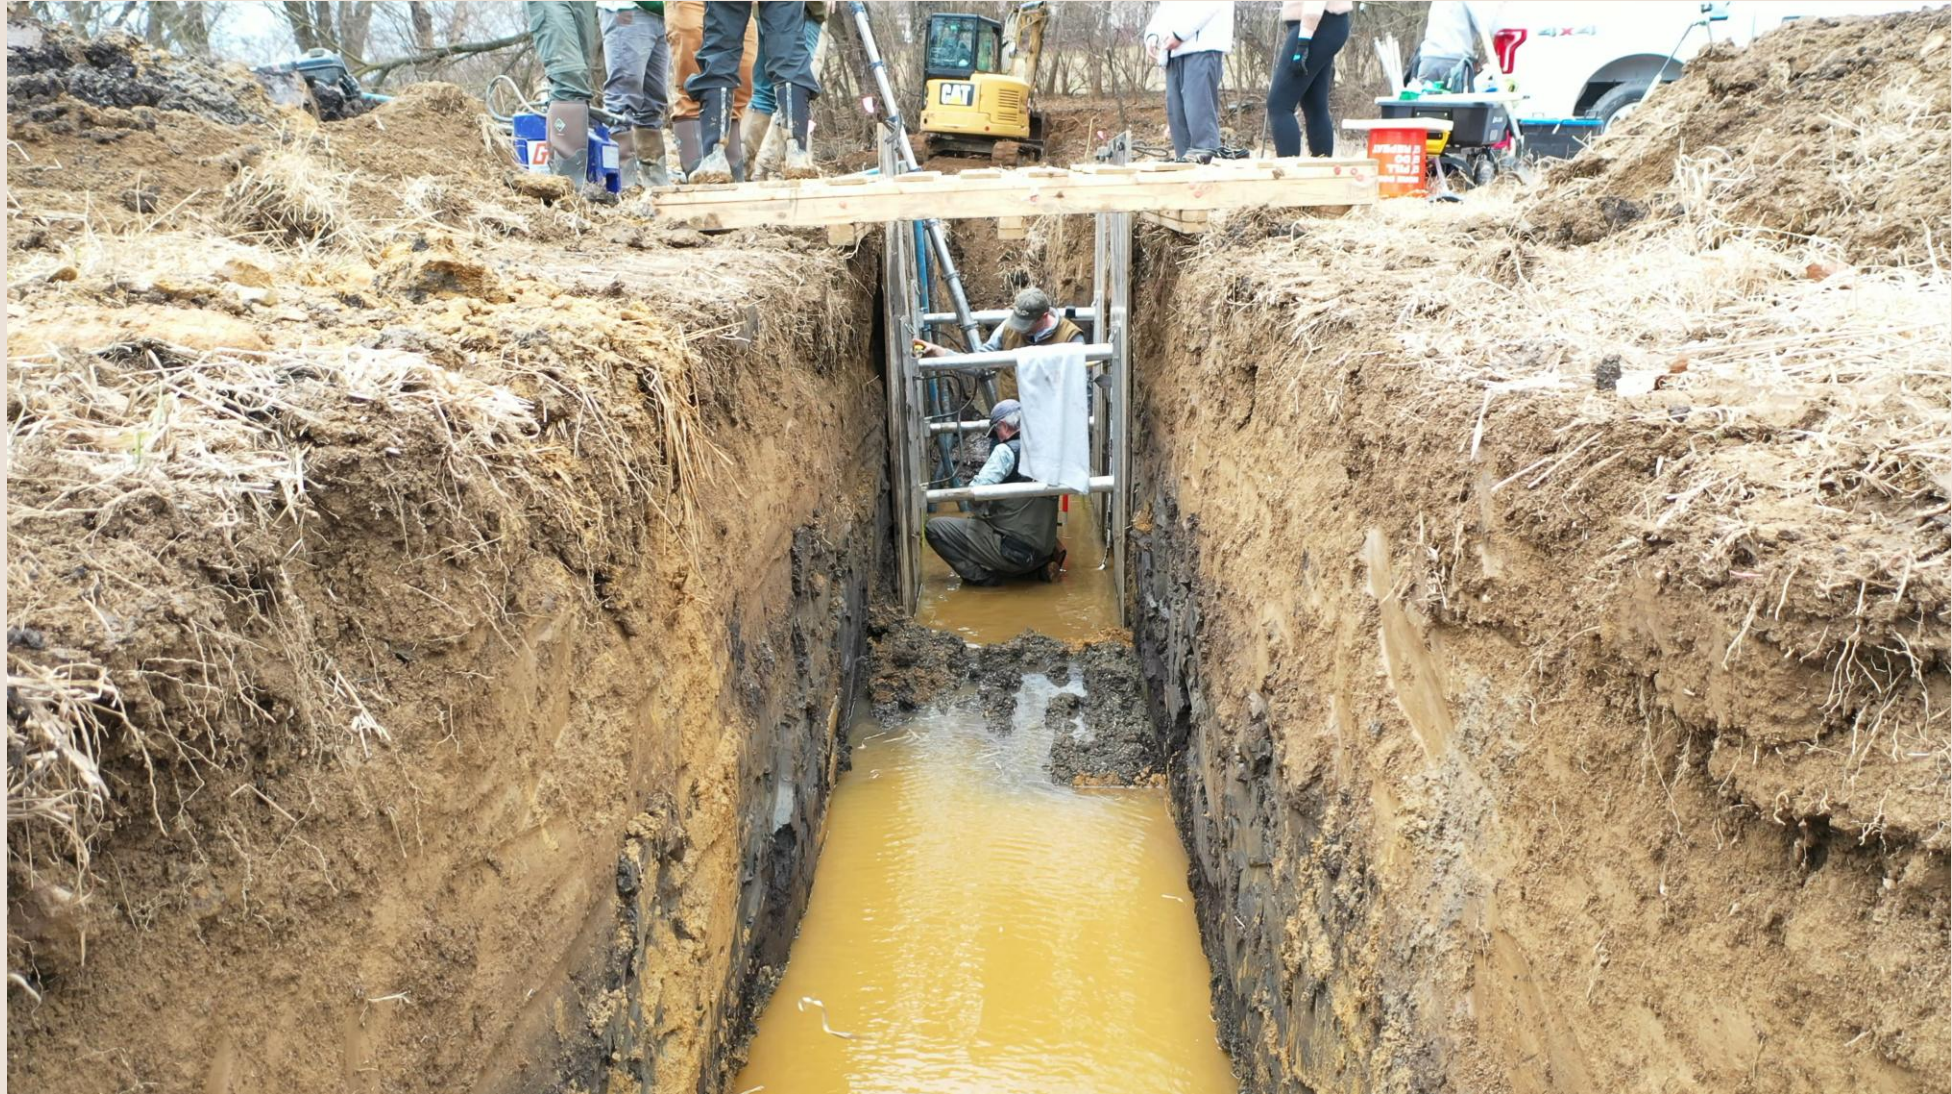
Little Conestoga Creek Groundwater

Woodcrest Villa Trench Site 2/13/23

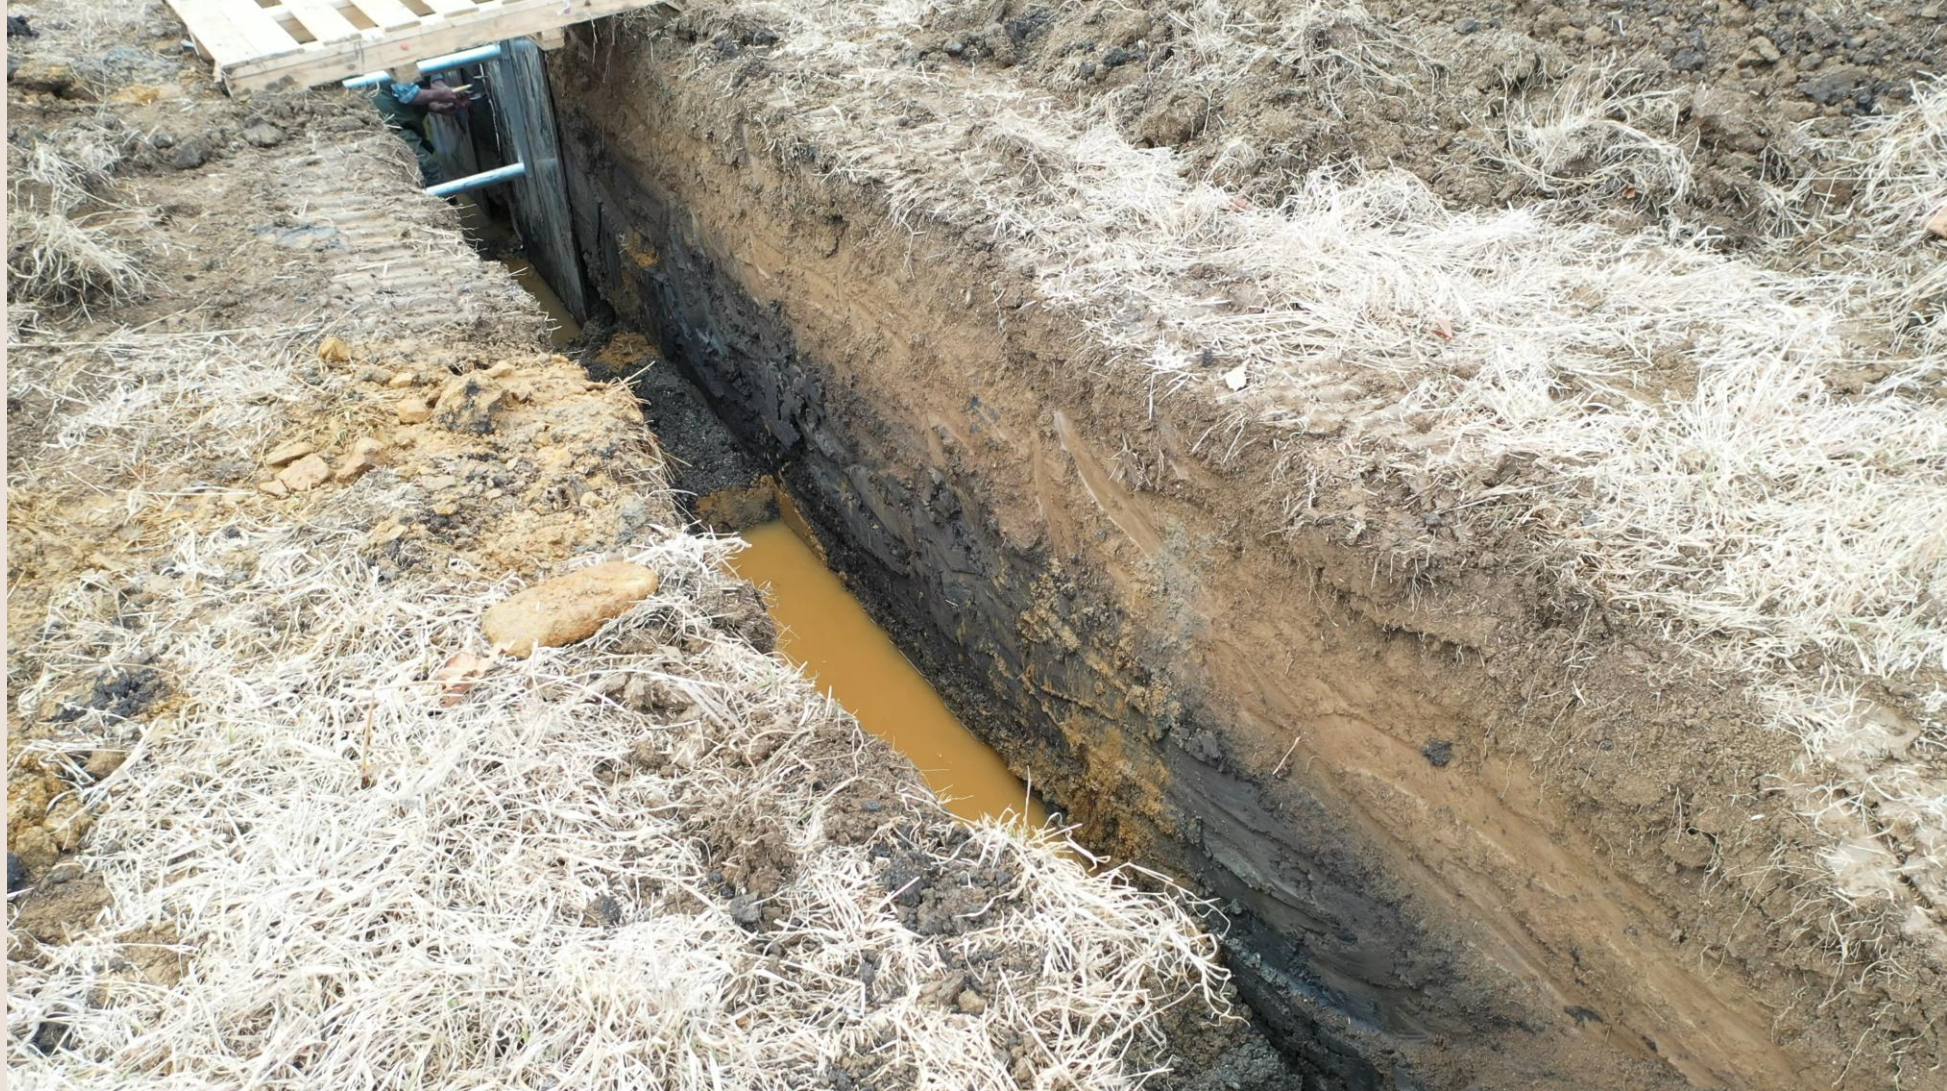
Little Conestoga Creek Groundwater

Woodcrest Villa Trench Site 2/13/23

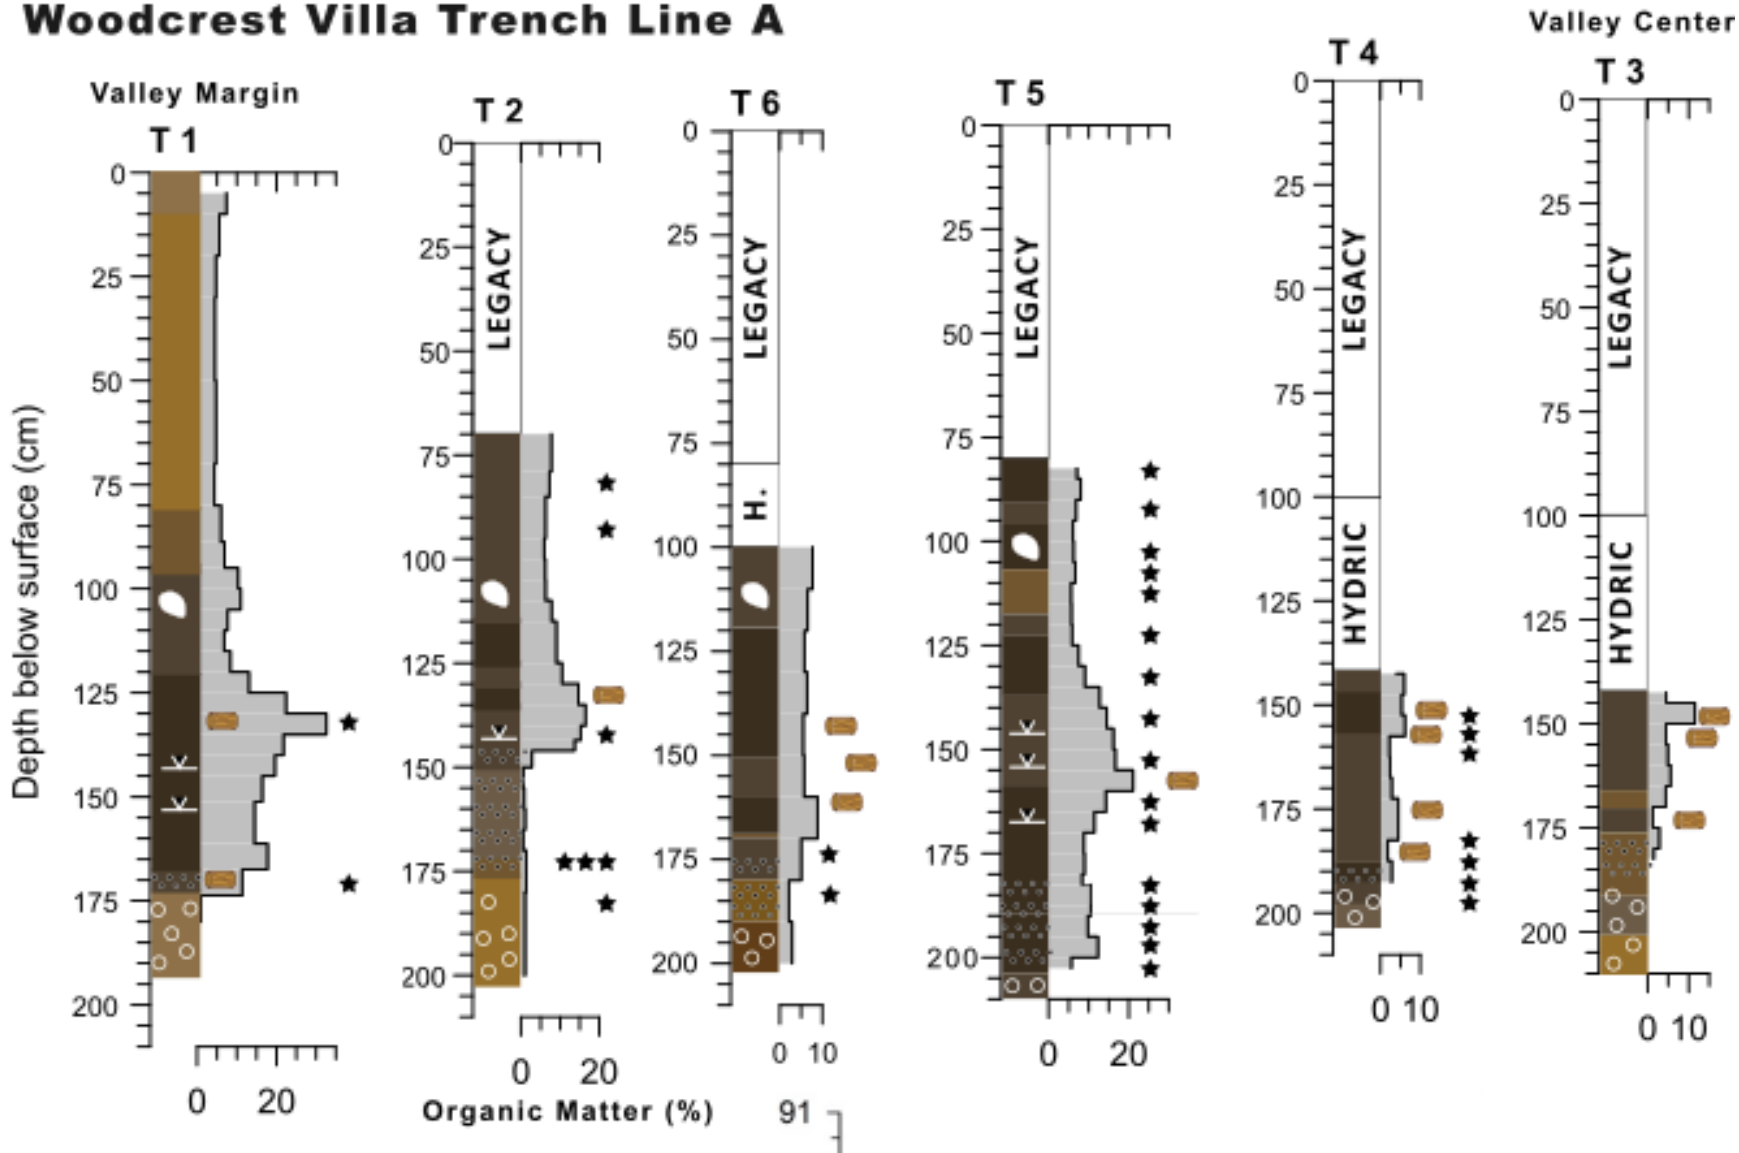
Woodcrest Villa Trench Line A

Little Conestoga Creek Stratigraphy - Woodcrest Villa Trench

Summary stratigraphy of Woodcrest Villa trenching

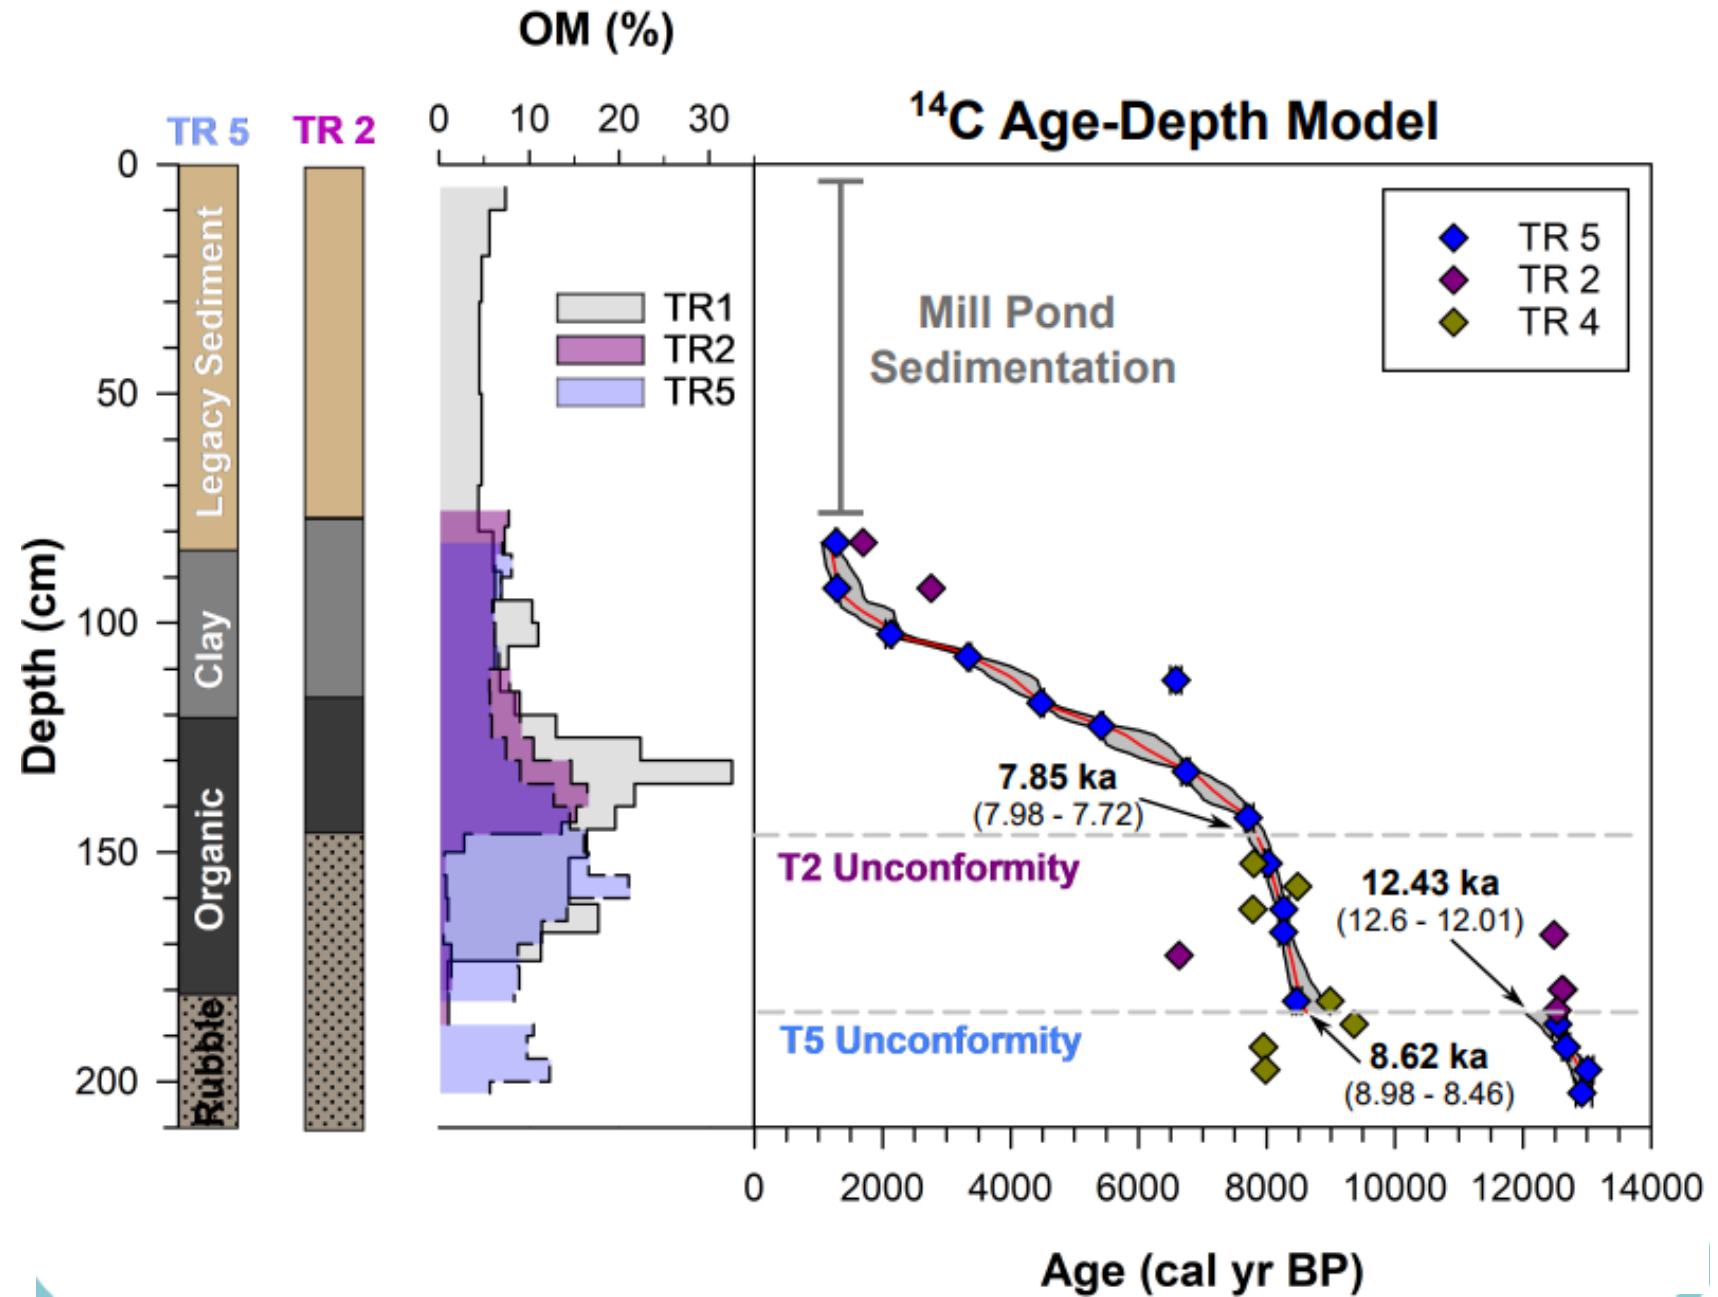
Timing of events

N = 34 Radiocarbon Dates

- Organic-poor hydric soil ages:
7.85 ka – 5.52 ka
- Organic-rich hydric soil ages:
9.23 – 7.62 ka
- Top of “Rubble” age:
12.43 - 12.49 ka

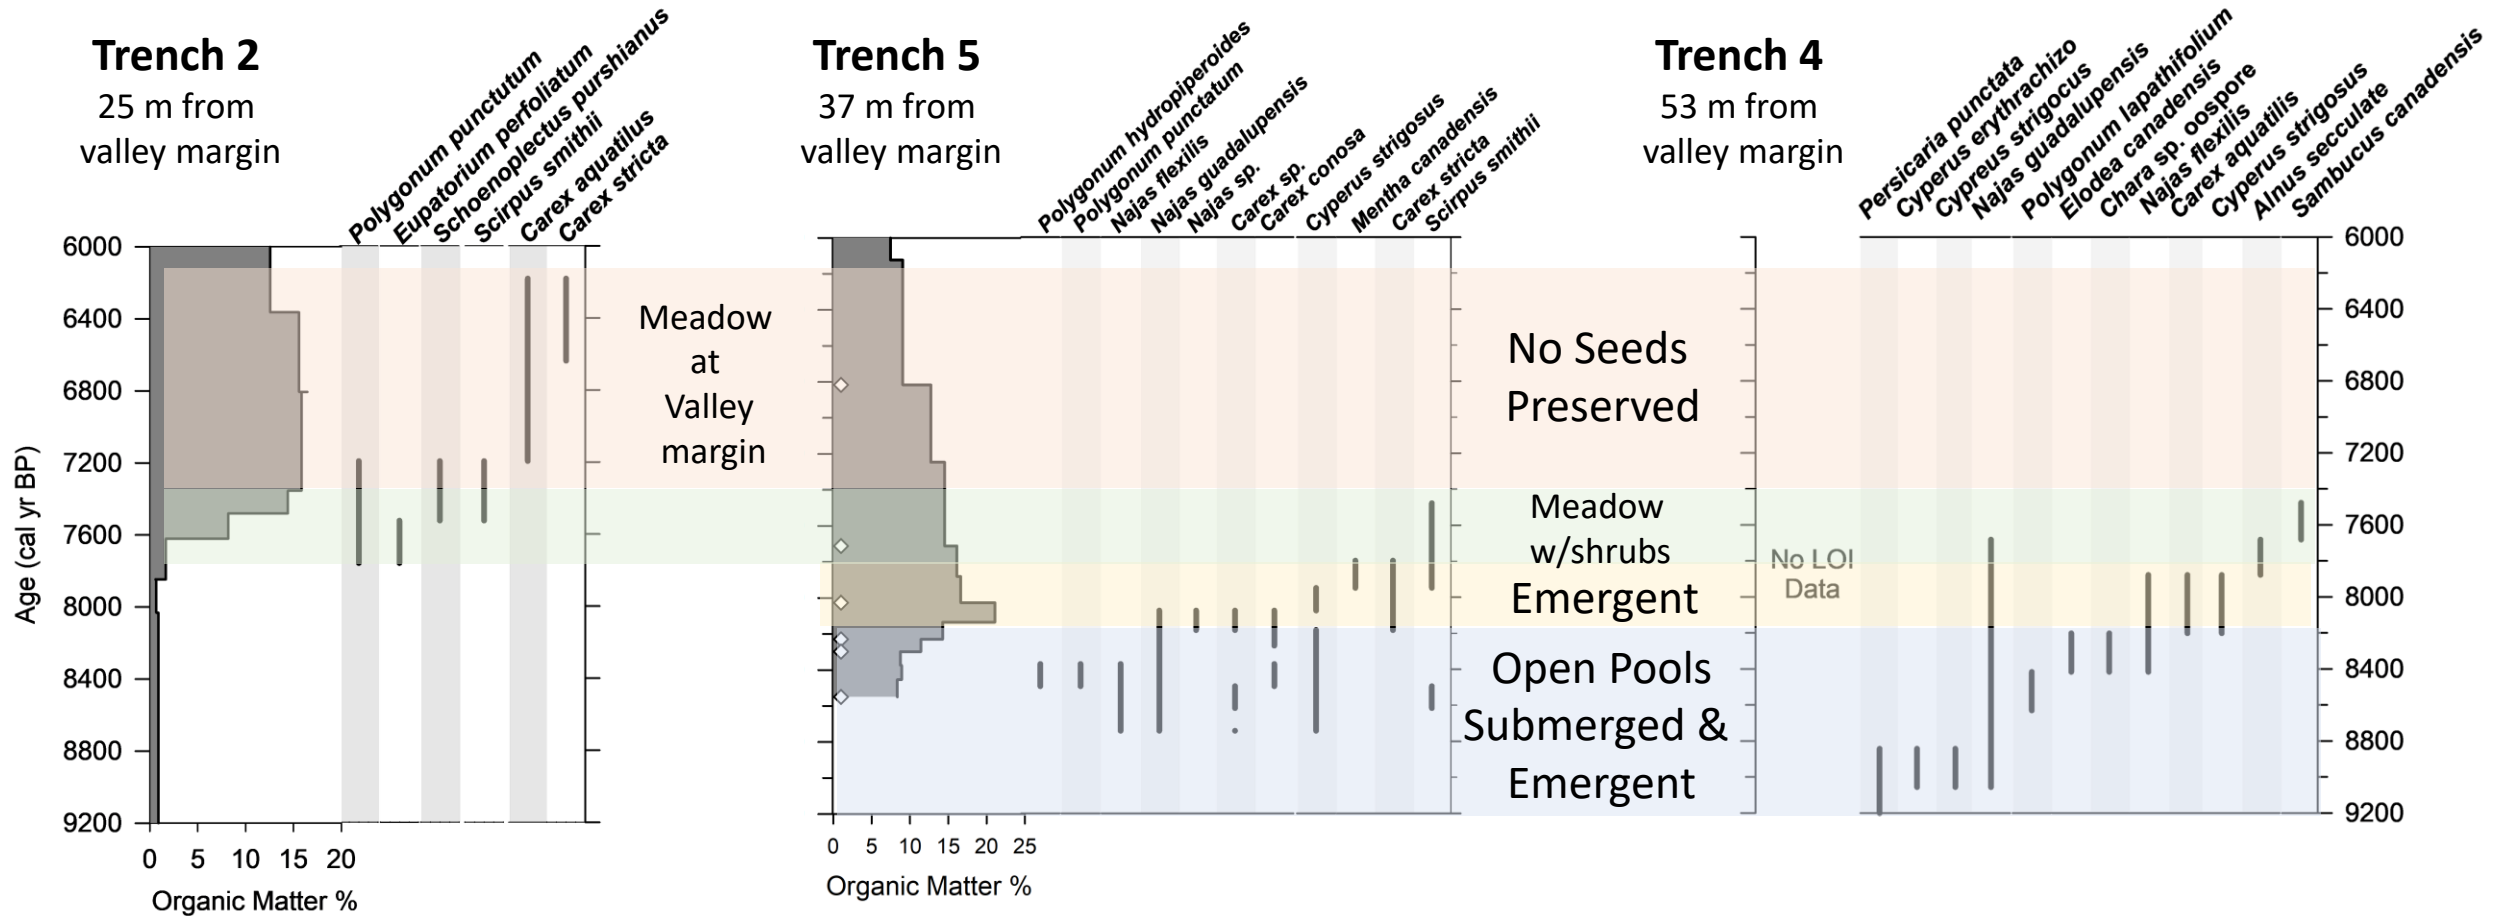
Tracking the growth and expansion of the floodplain wetland 9200 – 6000 yr BP at Little Conestoga Woodcrest Villa
