Conewago Creek Floodplain Restoration

Londonderry Township, Dauphin County, PA

March 4, 2026

Good Spring Run Floodplain Restoration

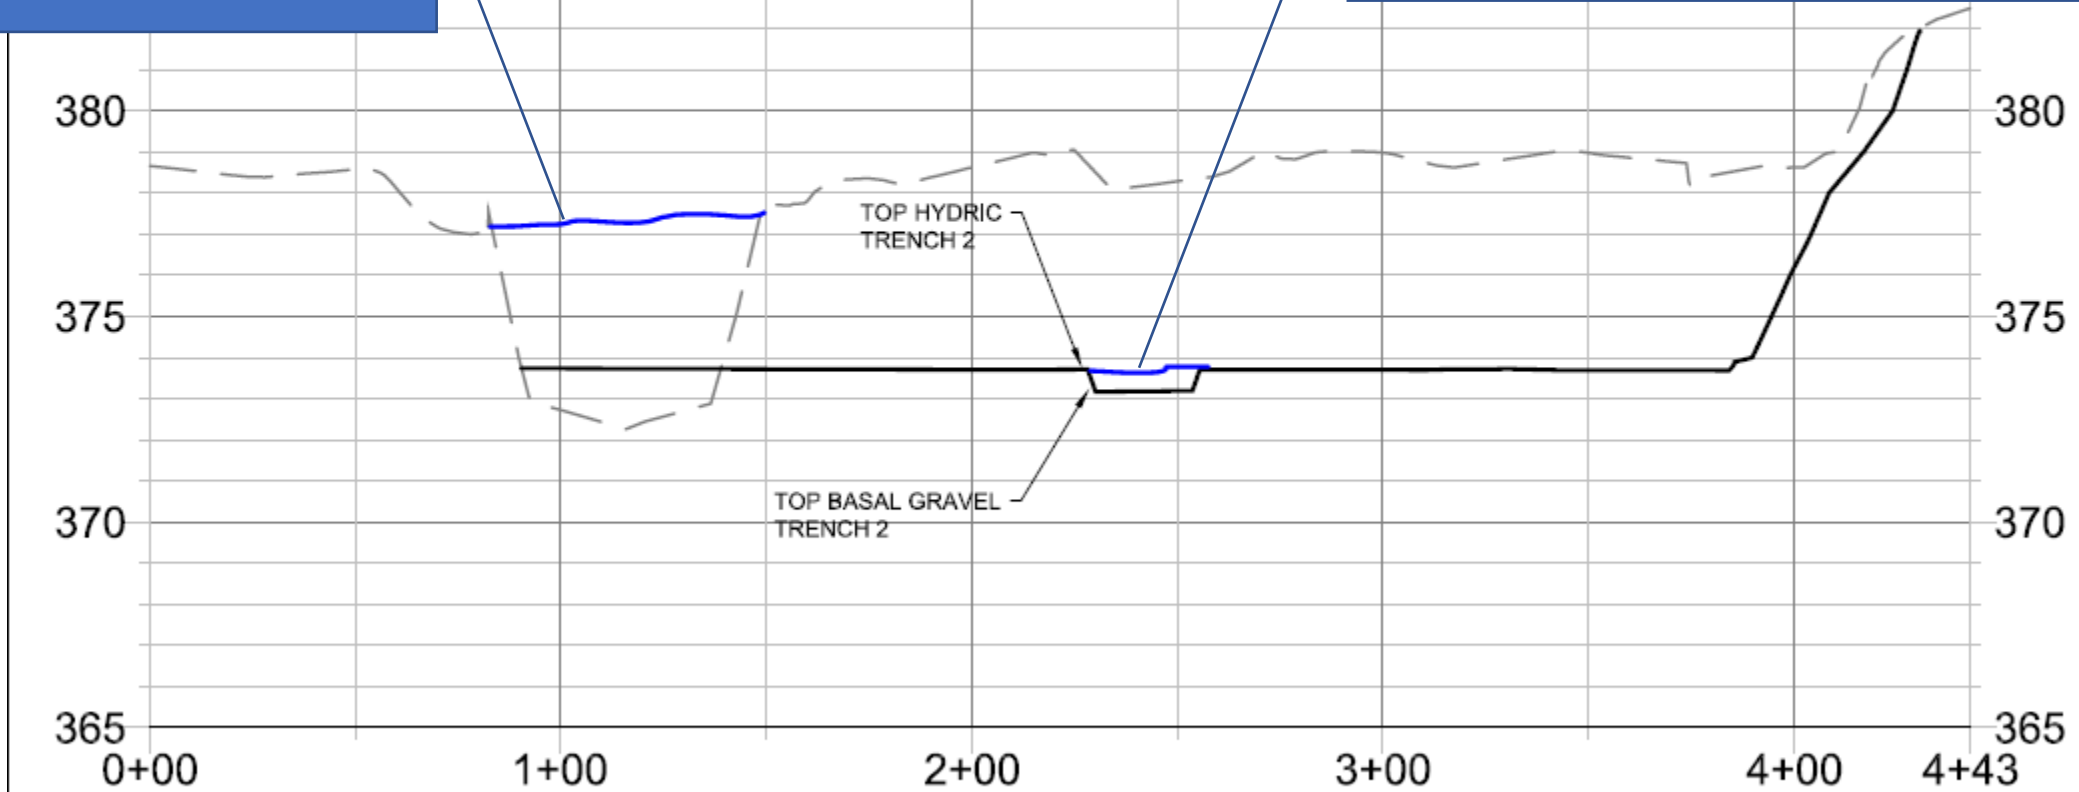
FLOODPLAIN SECTION AT TRENCH 2

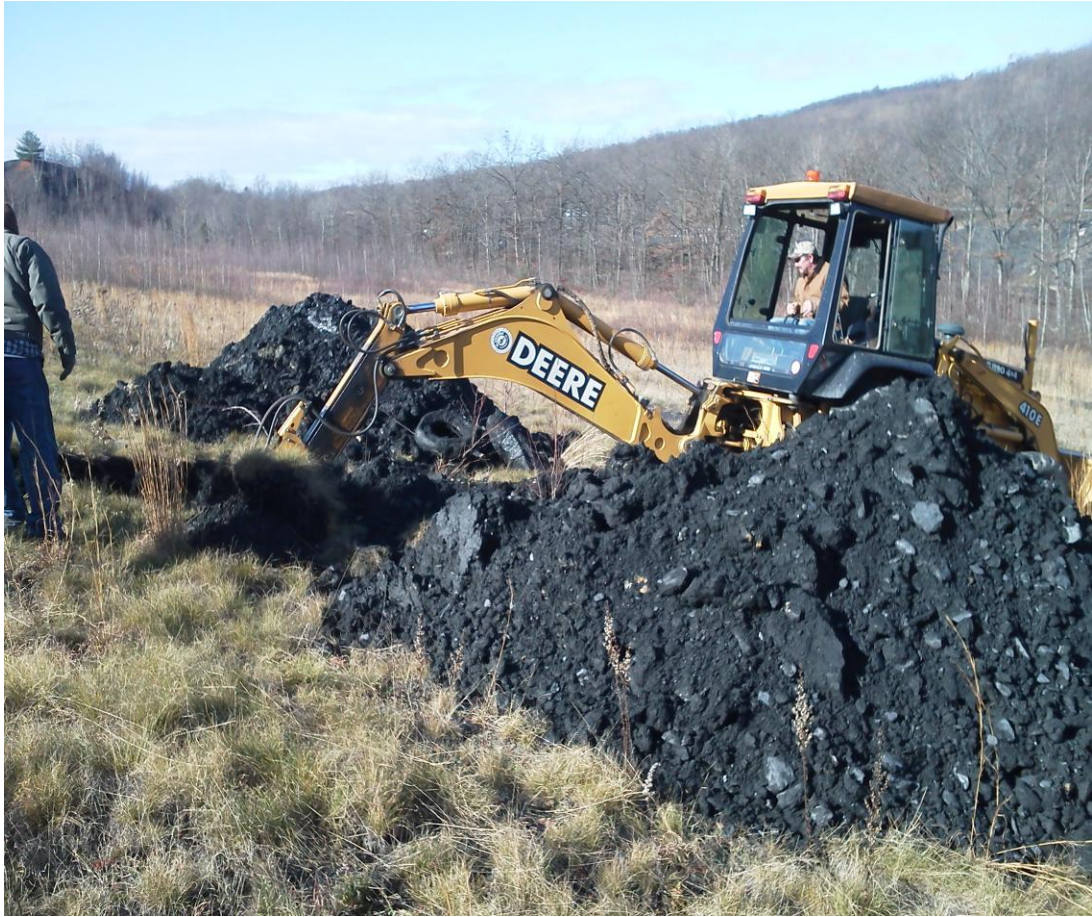
Subsurface Investigation (Trenches)

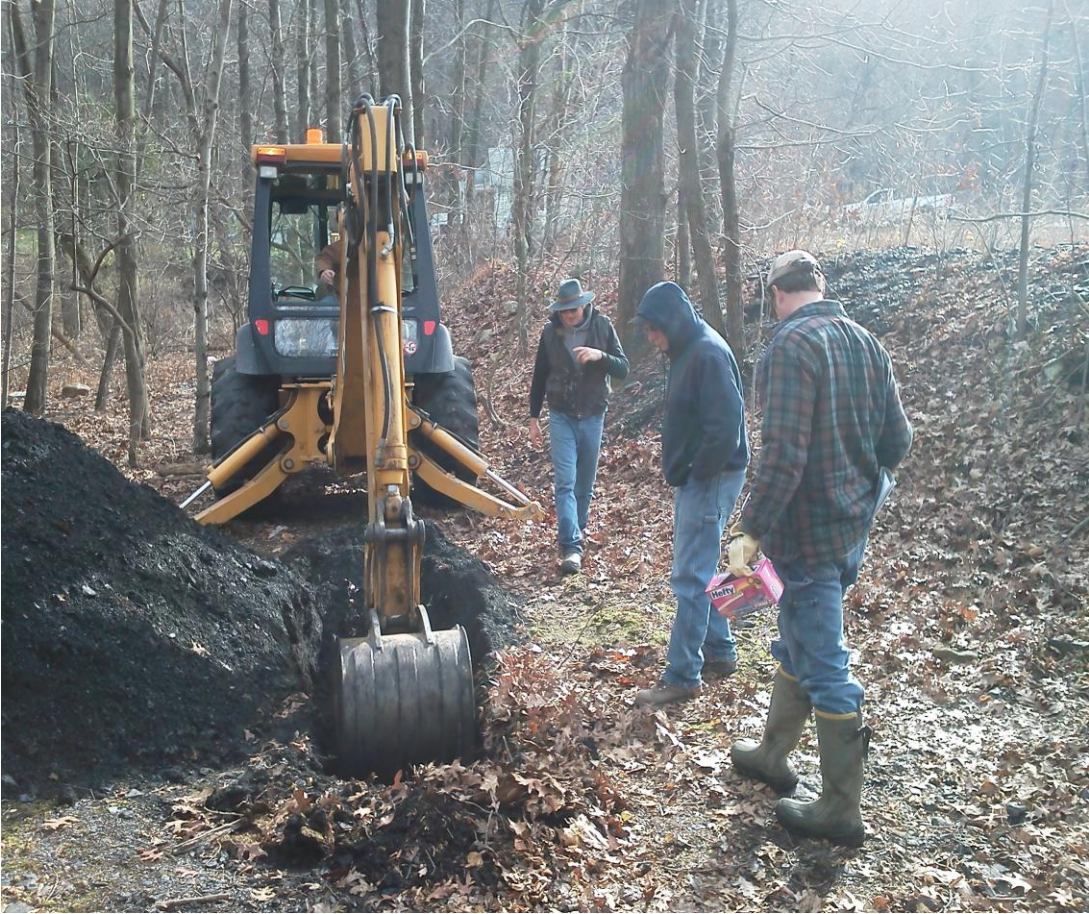
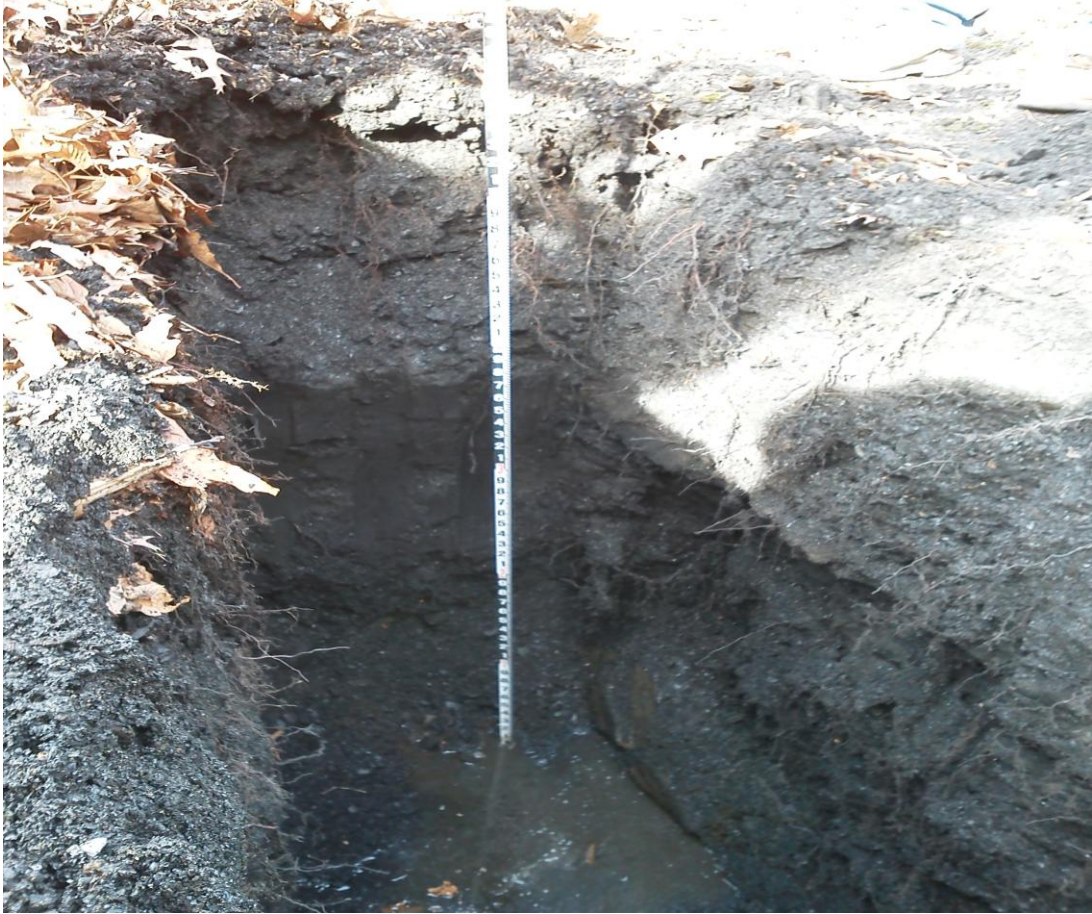
Subsurface Investigation (Trenches)

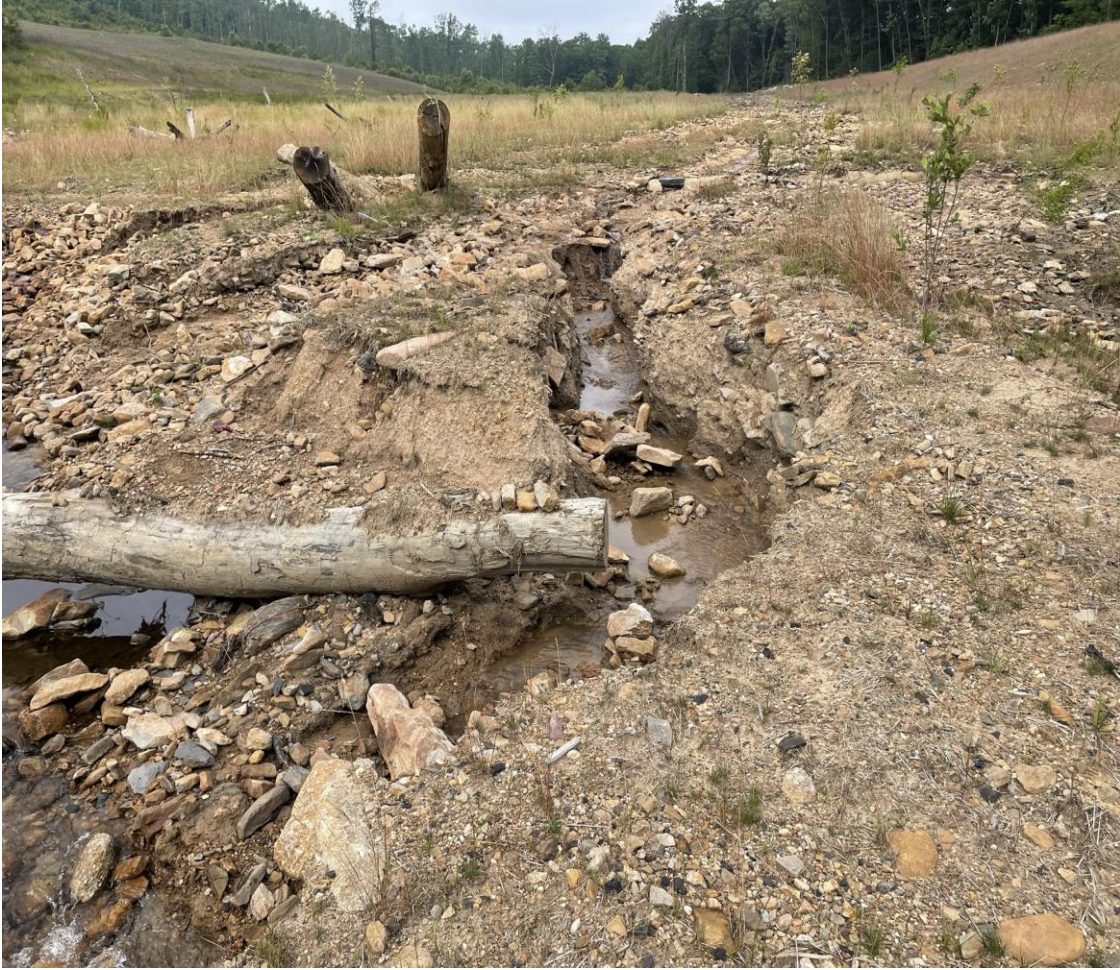
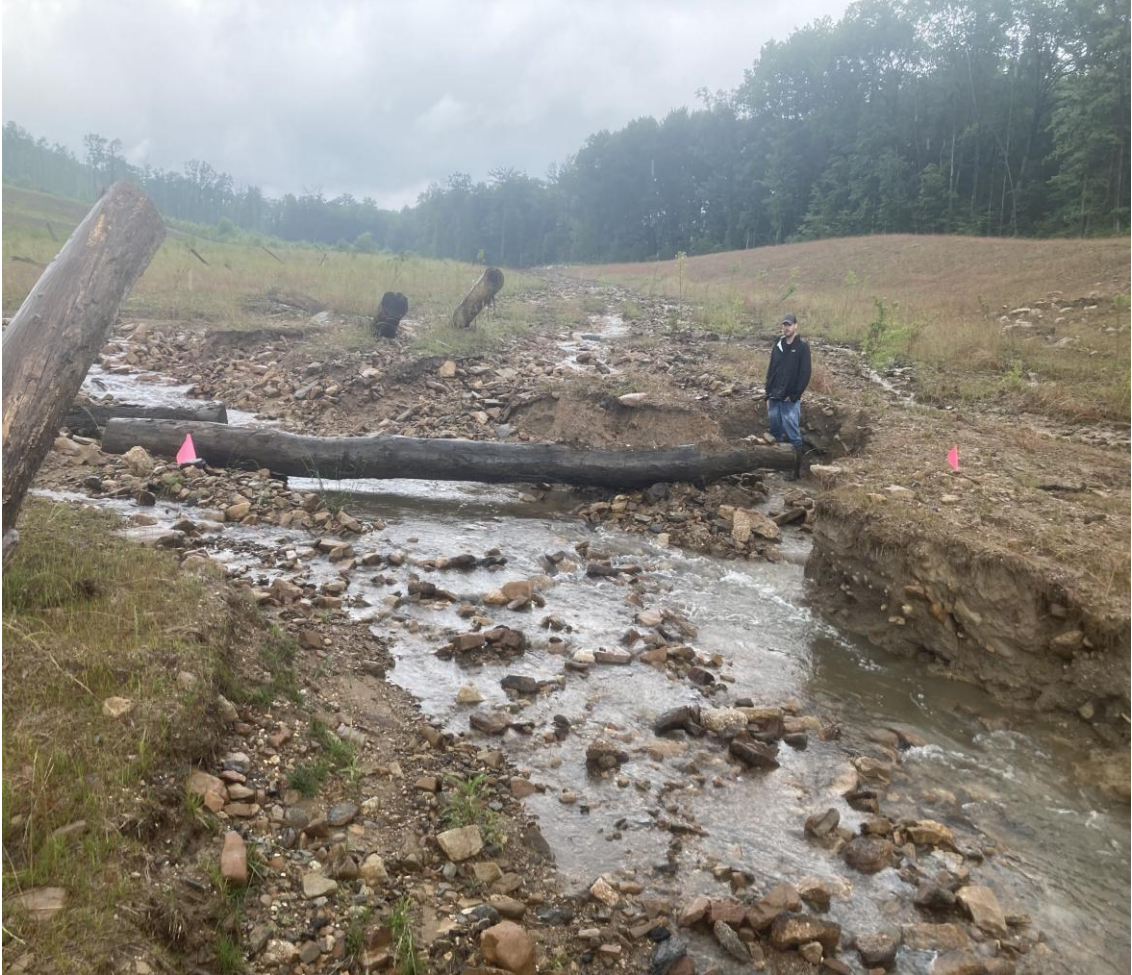
Flood Damage After Construction

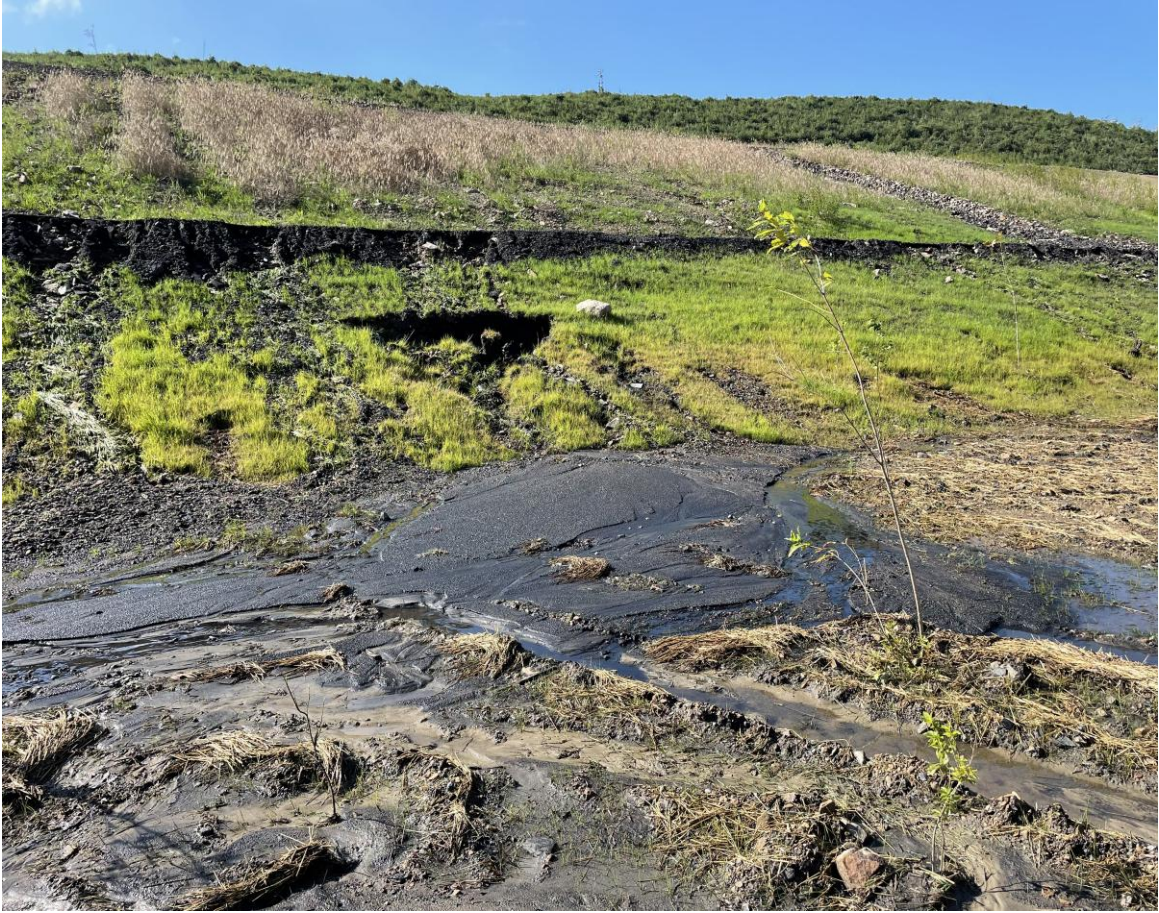
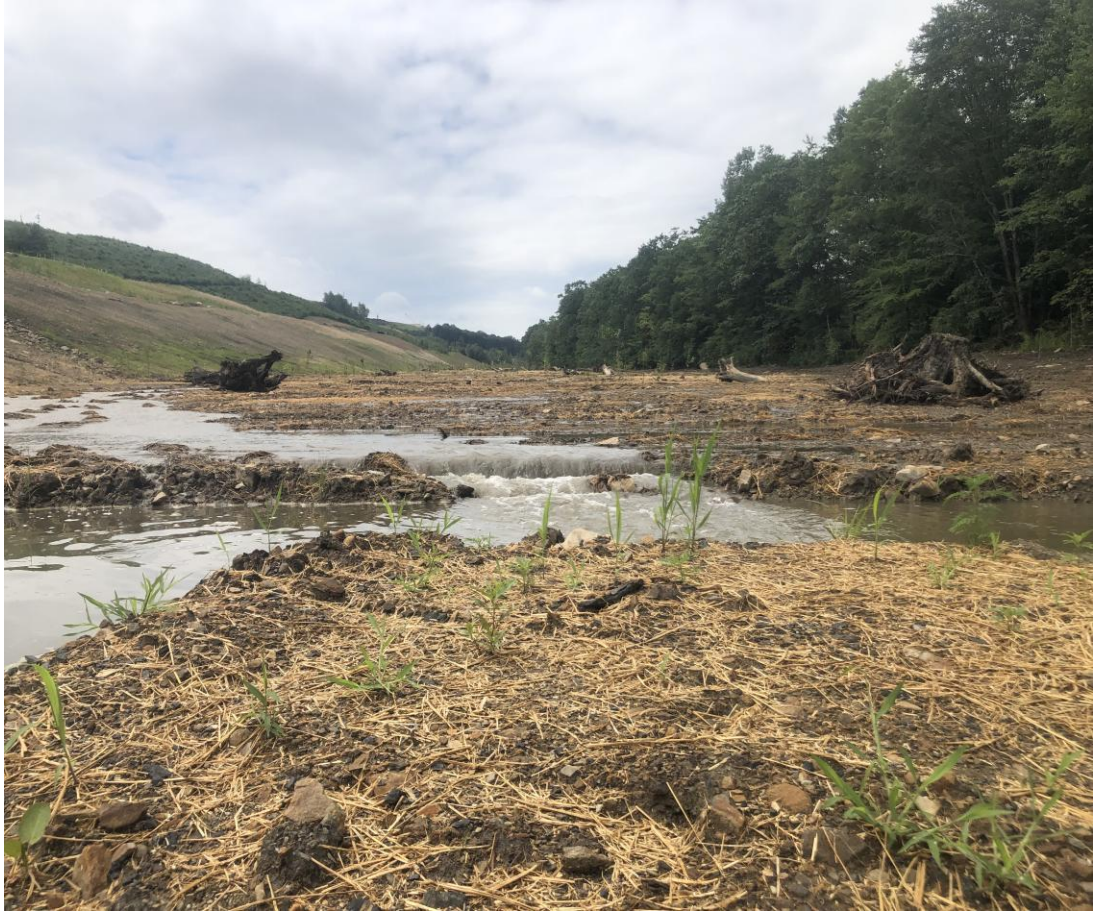
Flood Damage During Construction
