# Upper Cocalico Creek Watershed Permit Decision Matrix

**March 4, 2026**

**PA Aquatic Resource  
Restoration Conference**

Presented by Ben Ehrhart, PE, CFM  
LandStudies

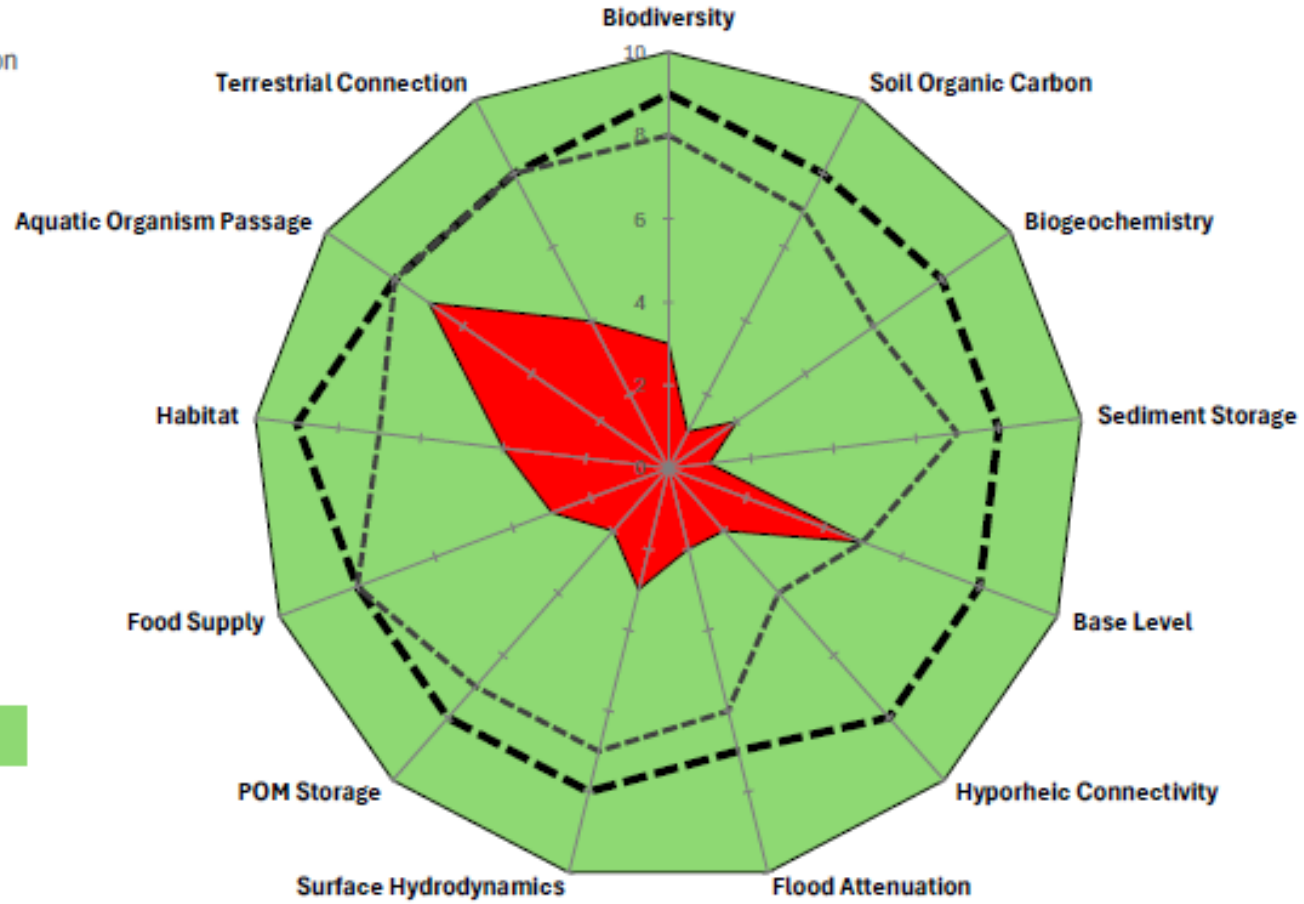
# Functional Categories

Functional Categories	Condition		Restoration Options		
	Natural	Degraded	Preferred Option	Option 2	No Action
Biodiversity	10	3	9	8	3
Soil Organic Carbon	10	1	8	7	1
Biogeochemistry	10	2	8	6	2
Sediment Storage	10	1	8	7	1
Base Level	10	5	8	5	5
Hyporheic Connectivity	10	2	8	4	2
Flood Attenuation	10	2	7	6	2
Surface Hydrodynamics	10	3	8	7	3
POM Storage	10	2	8	7	2
Food Supply	10	3	8	8	3
Habitat	10	4	9	7	4
Aquatic Organism Passage	10	7	8	8	7
Terrestrial Connection	10	4	8	8	4
<b>Average Resource Function</b>	<b>10.0</b>	<b>3.0</b>	<b>8.1</b>	<b>6.8</b>	<b>3.0</b>
Total Aquatic Resource Area (ac)	8.50	1.00	5.50	5.50	1.00
<b>Functional Magnitude</b>	<b>85.0</b>	<b>3.0</b>	<b>44.4</b>	<b>37.2</b>	<b>3.0</b>
Function Relative to Natural Condition		4%	52%	44%	4%
Function Relative to Degraded Condition			1481%	1241%	100%
